LESSONS OF 2015 NEPAL EARTHQUAKE DISASTER

A Short Report on Effects of
7.8 M_w Earthquake of 25 April 2015 and Its Aftershocks
(Including Photo Documentation)

Sujan Malla, Dr. Eng.

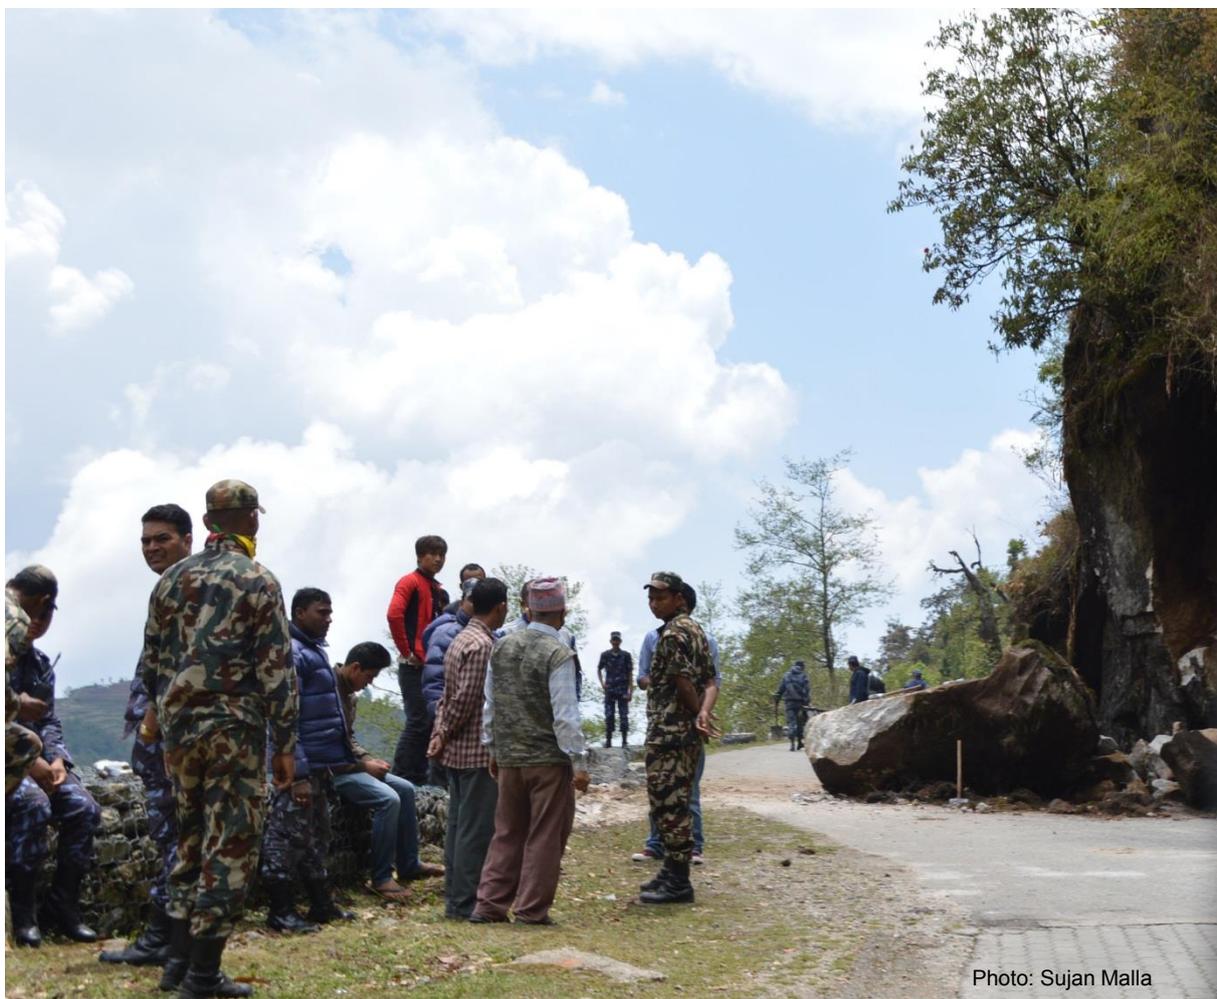
Photo 1 Rockfall practically blocking Tribhuvan Highway near Sim Bhanjhang on 27 April 2015

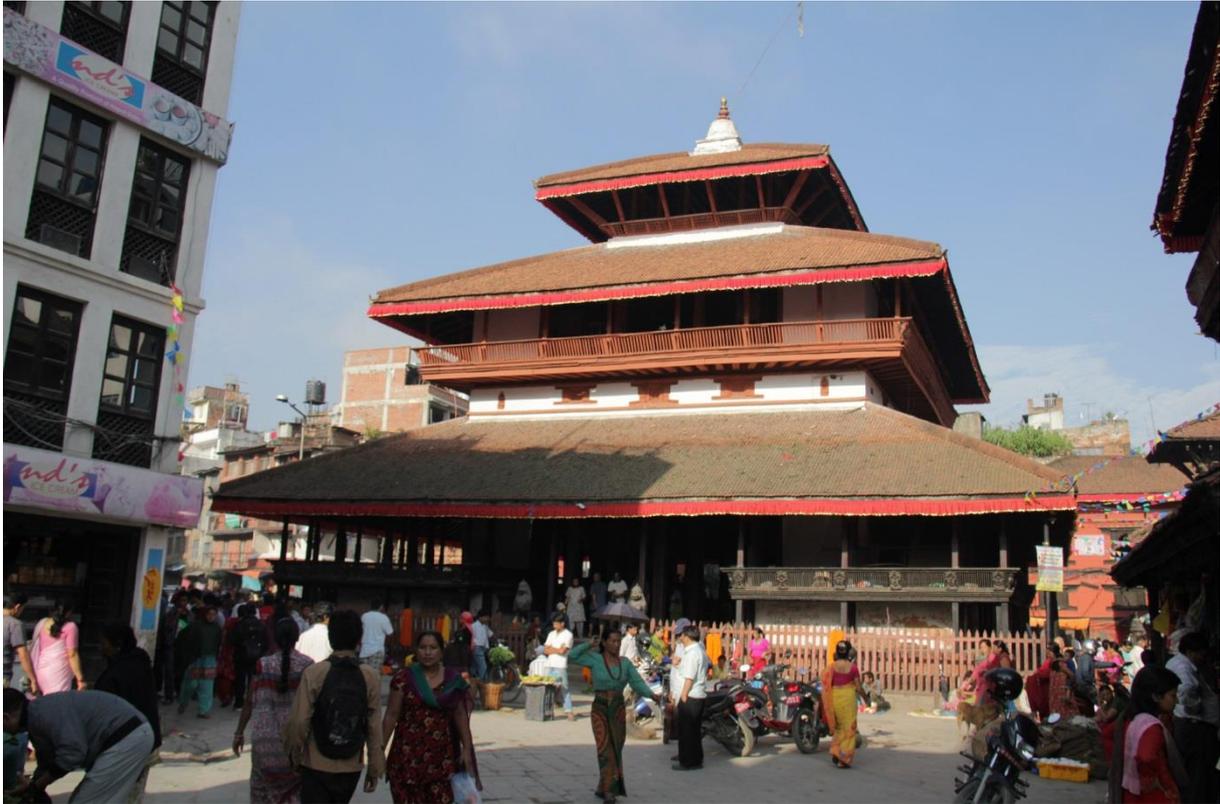
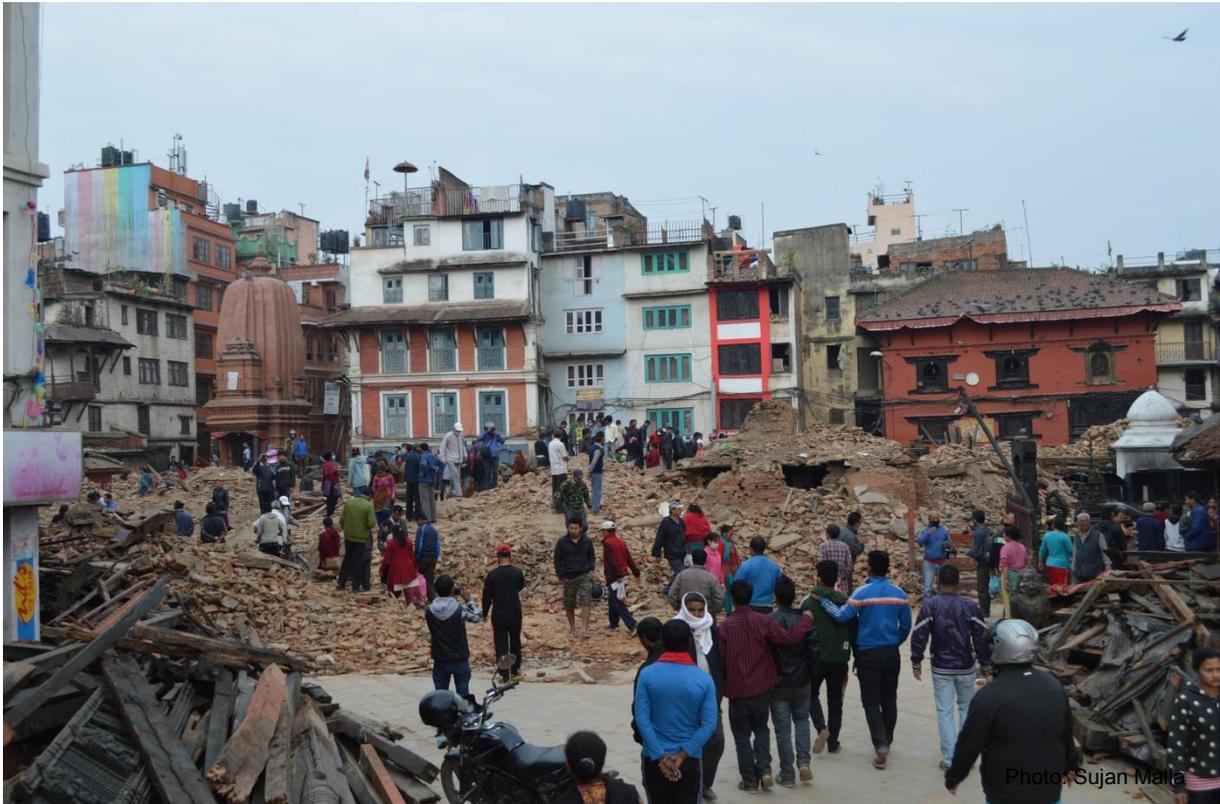
Photo 4 Kasthamandap Temple in Kathmandu before and after the 25 April 2015 earthquake

The earthquake of 25 April 2015 had a devastating effect on the ancient temples and heritage structures (see Photo 2 to Photo 16), many of which are parts of the UNESCO World Cultural Heritage sites in the Kathmandu Valley. A disproportionately high percentage of such structures collapsed during to the 2015 earthquake shaking, compared to the brick masonry and reinforced concrete frame buildings in their immediate neighborhood, most of which did not collapse and mostly suffered only minor visible damage.

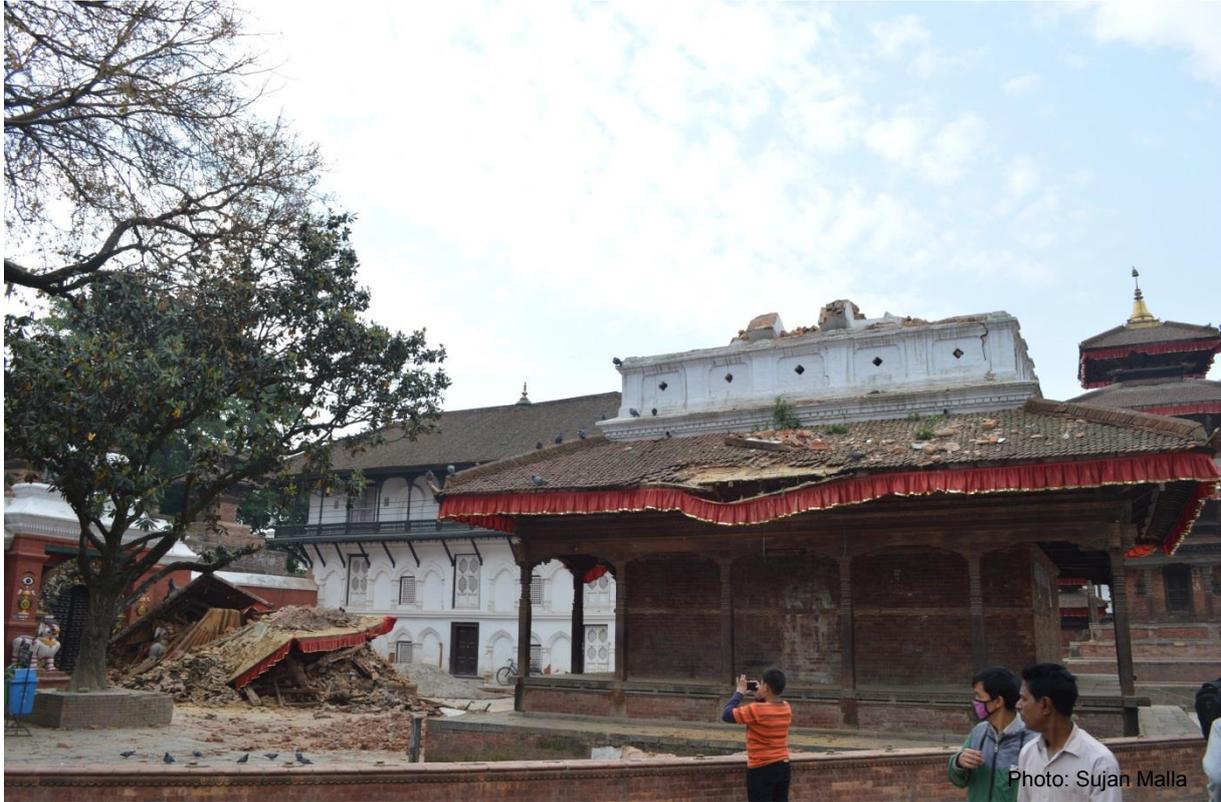
Photo 5 Pagoda temple whose detached upper storey landed several meters away at Kathmandu Durbar Square

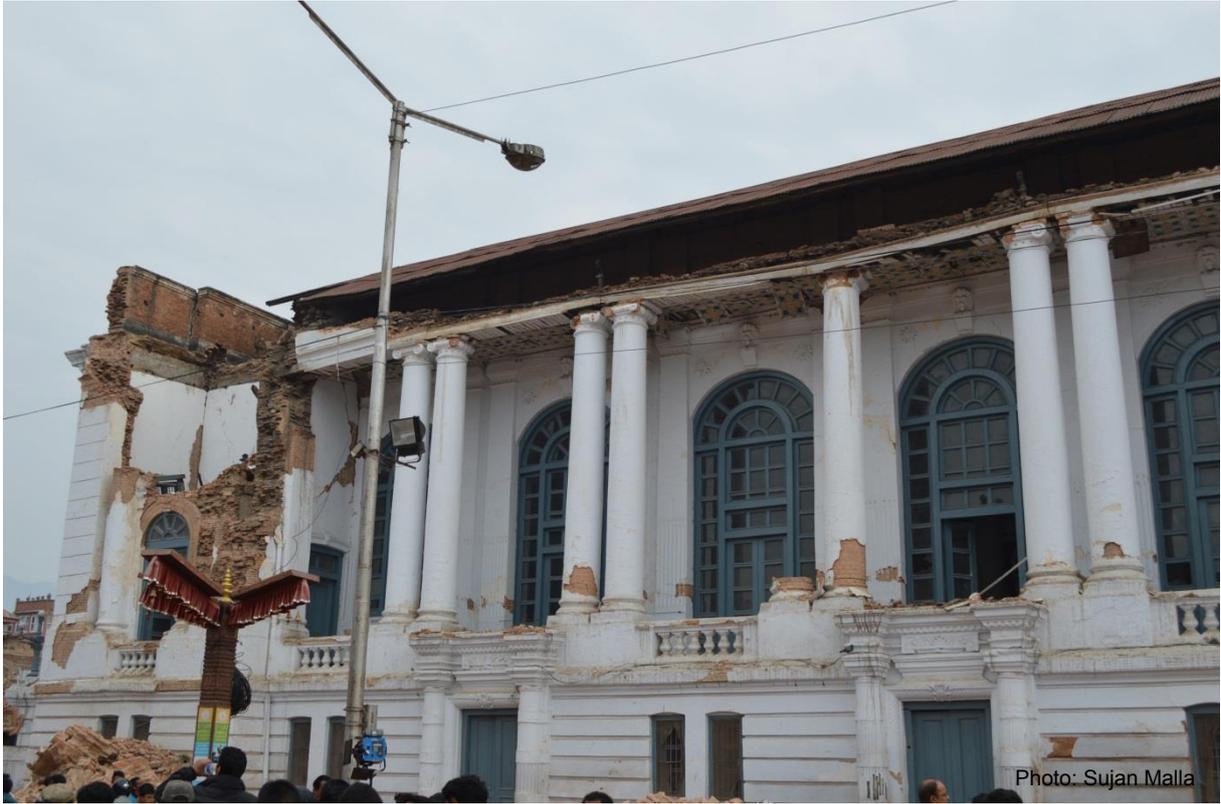
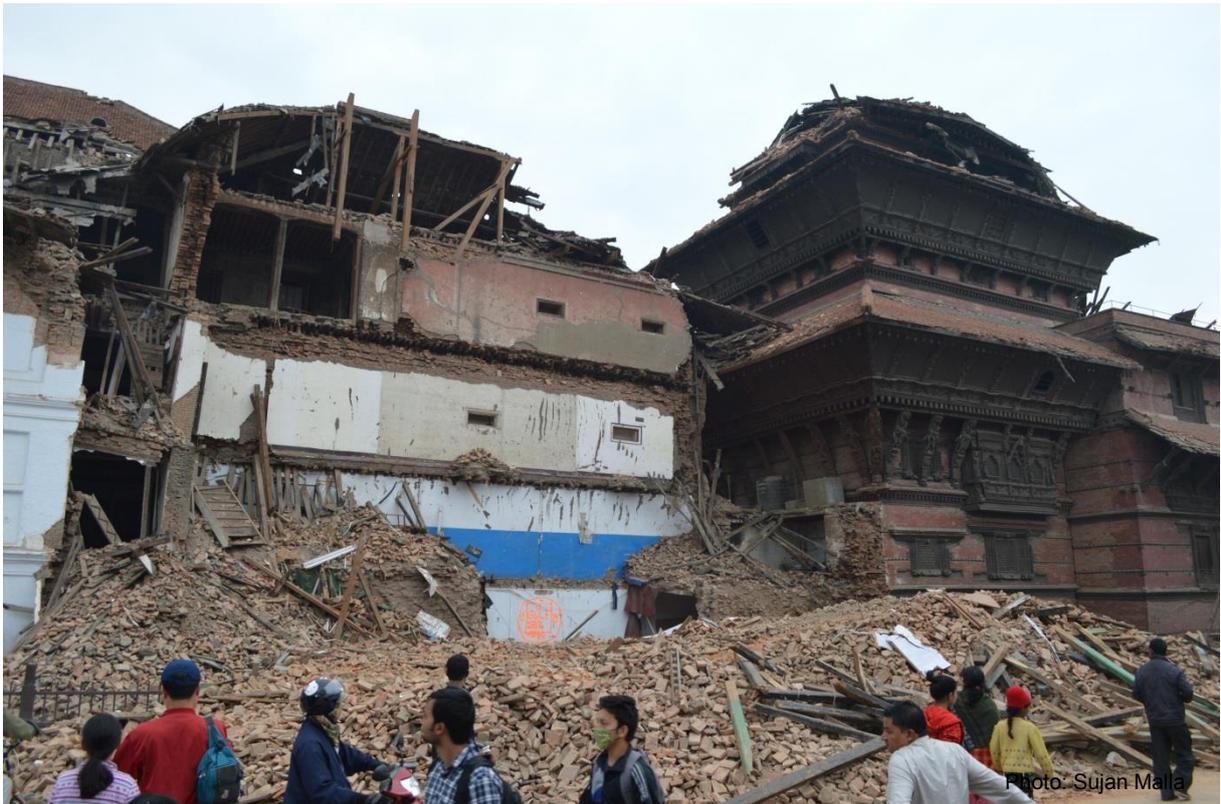
Photo 7 Structural damages to palace complex, Kathmandu Durbar Square

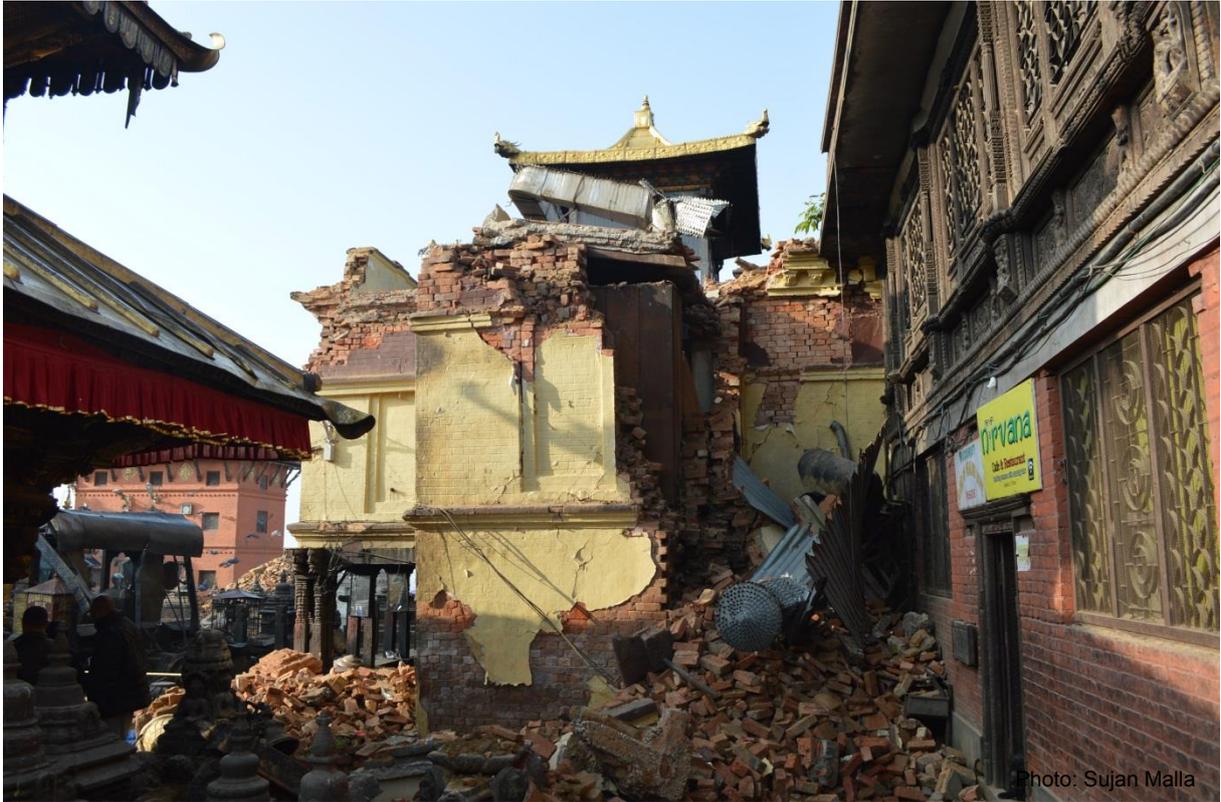
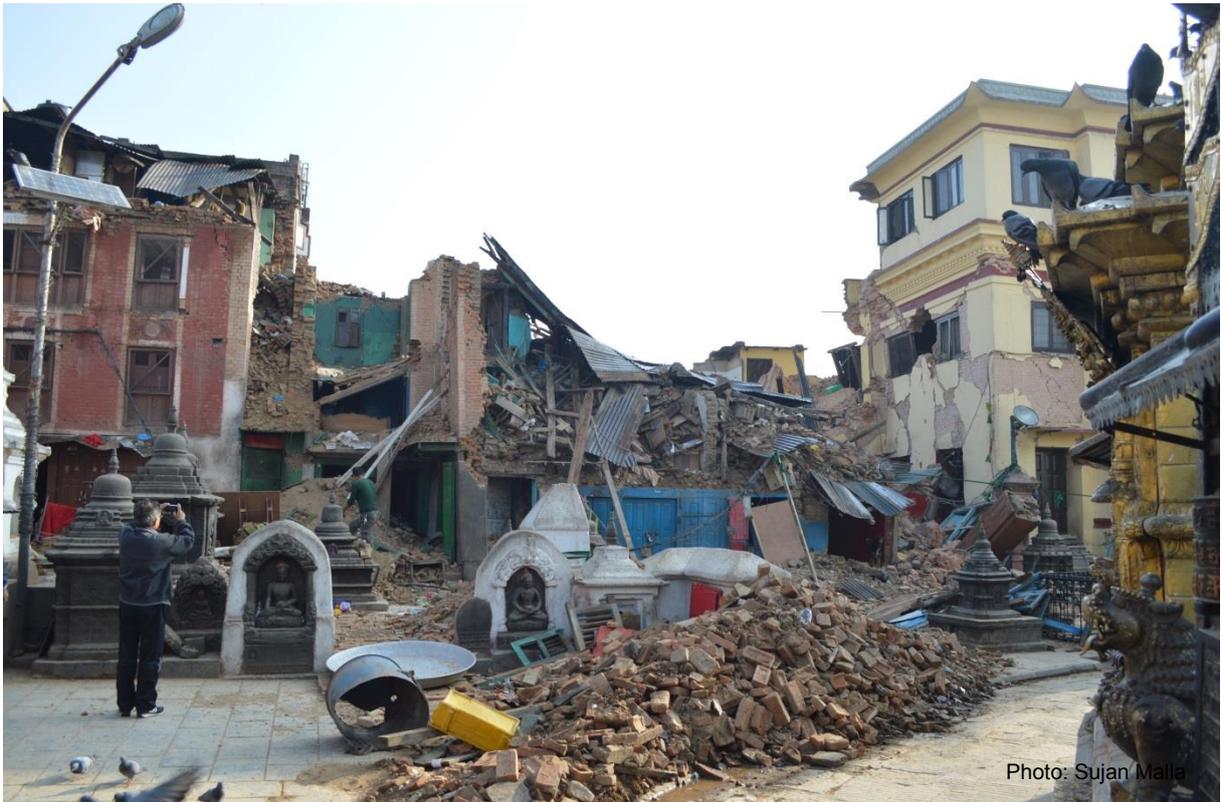
Photo 8 Collapsed buildings on Swayambhu hill

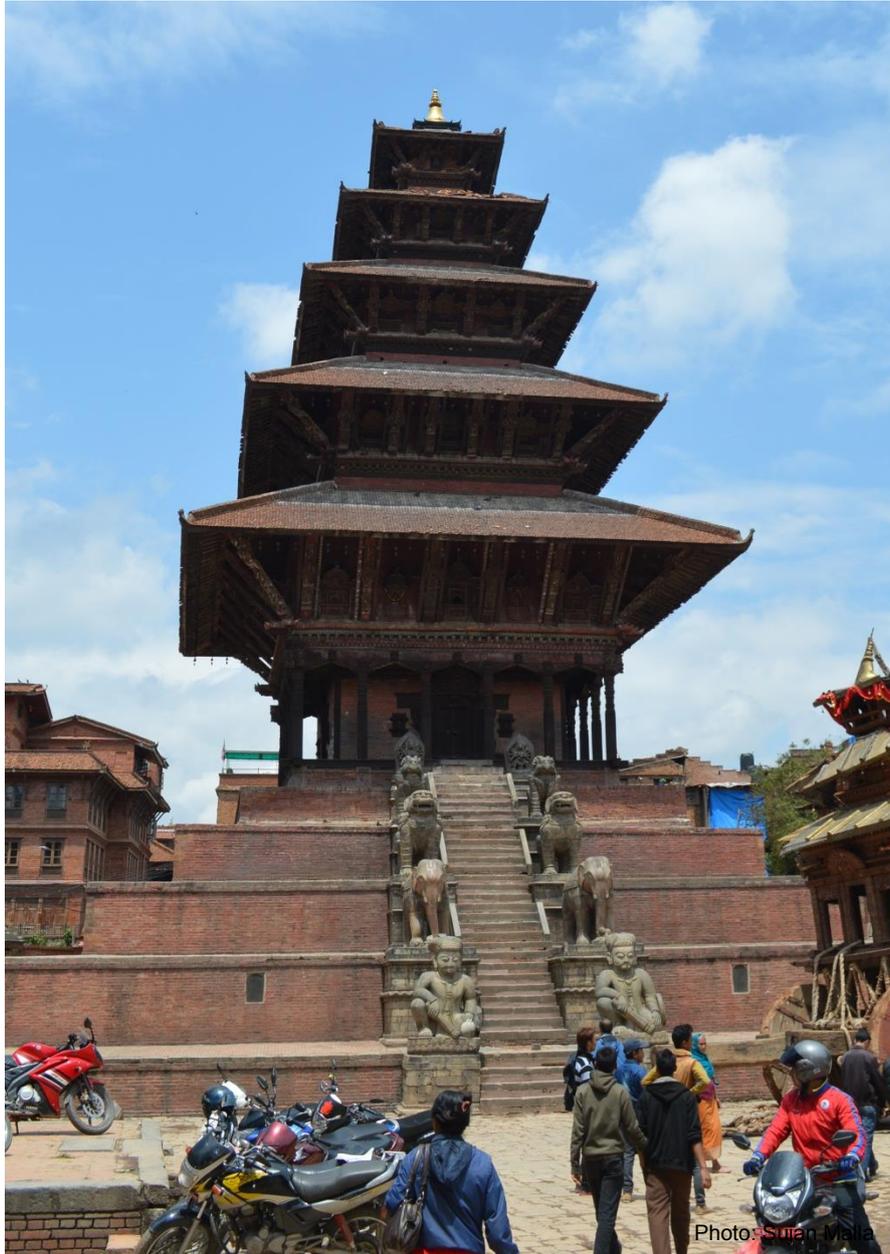
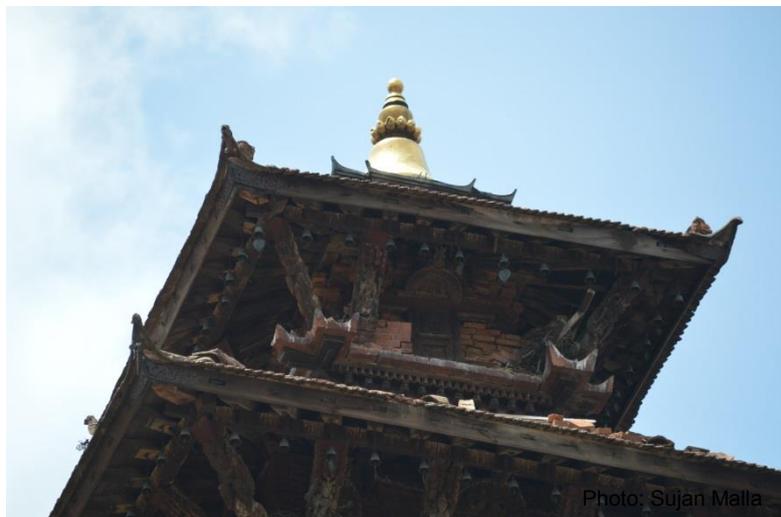
Photo 12 Nyatapola Temple at Taumadhi Square, Bhaktapur with damage in the uppermost level

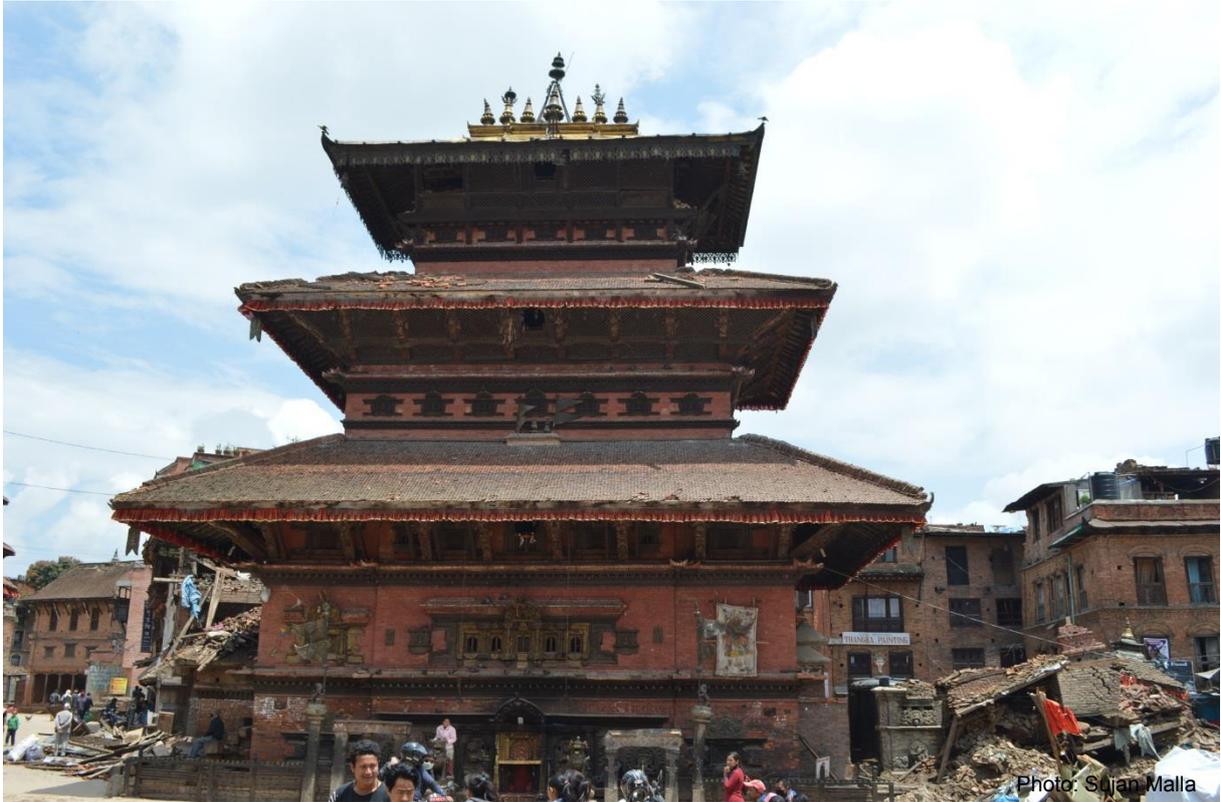
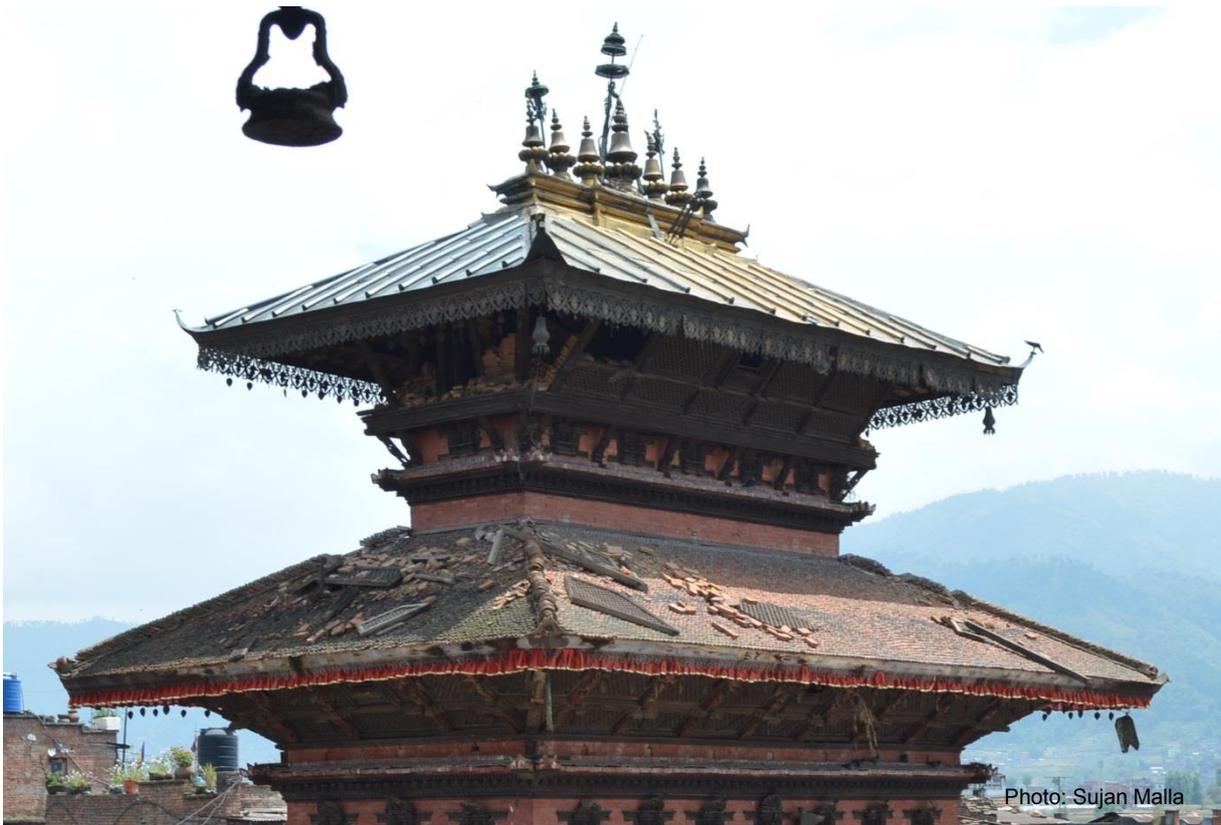
Photo 13 Bhairavnath Temple at Taumadhi Square, Bhaktapur with significant damage in the uppermost level

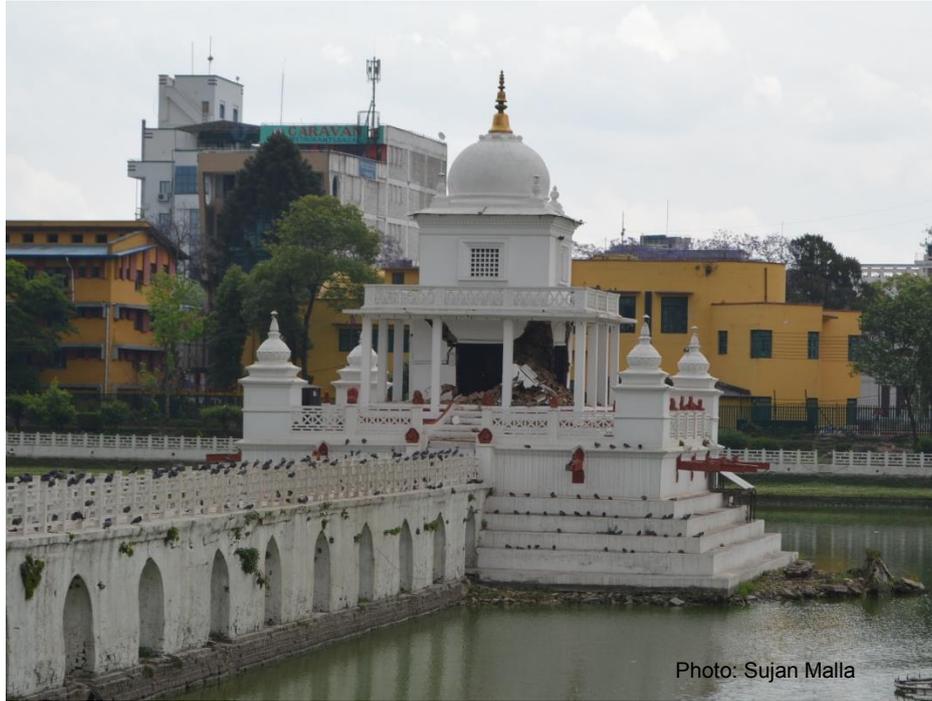
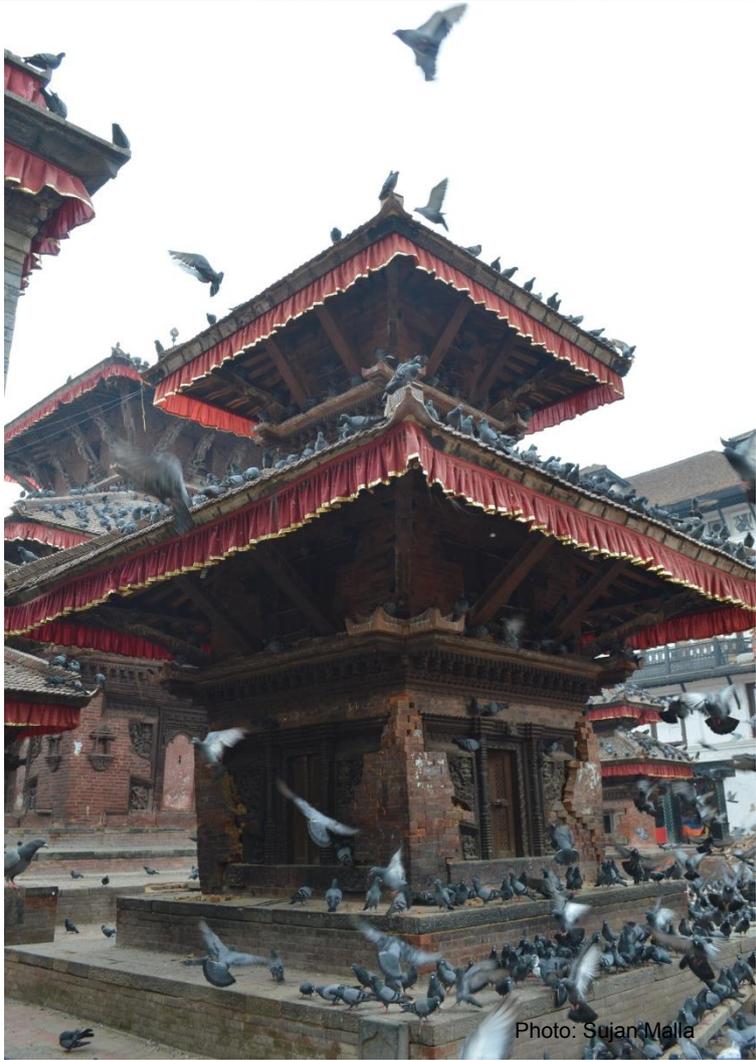
Photo 14 Temples with substantial damage in Kathmandu

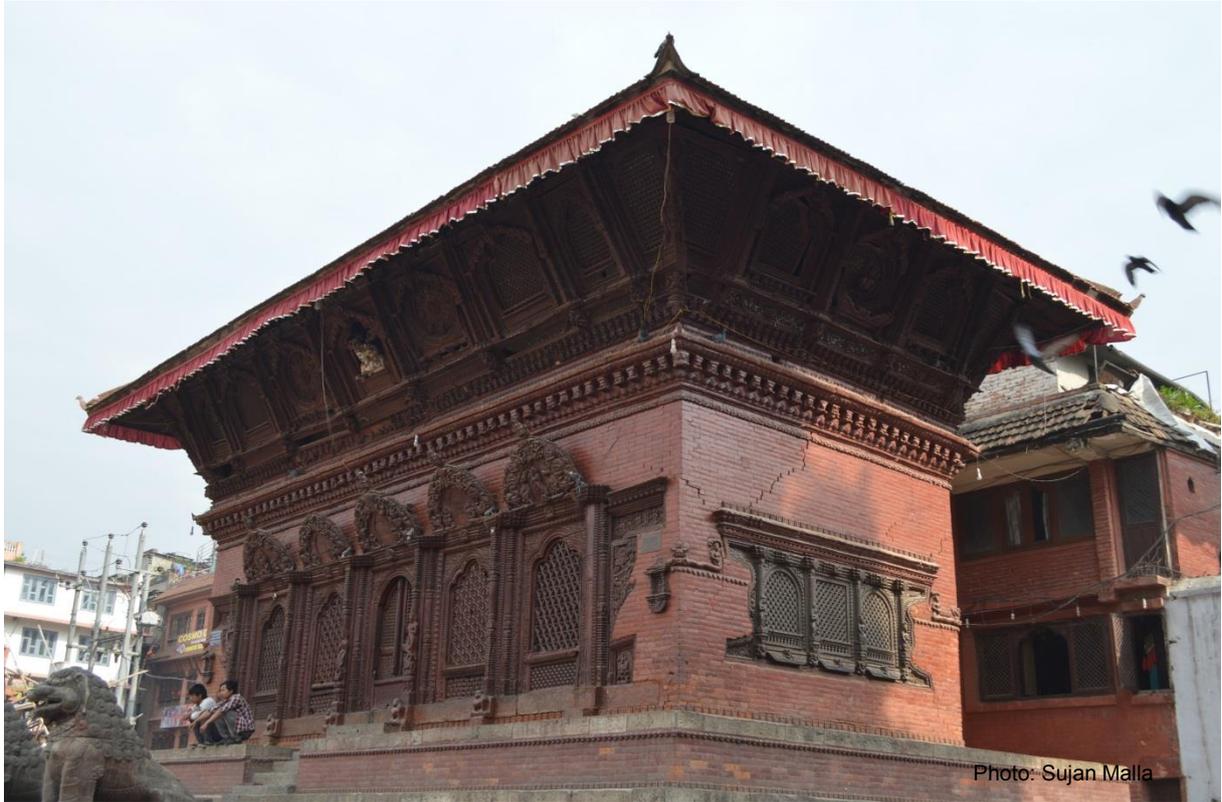
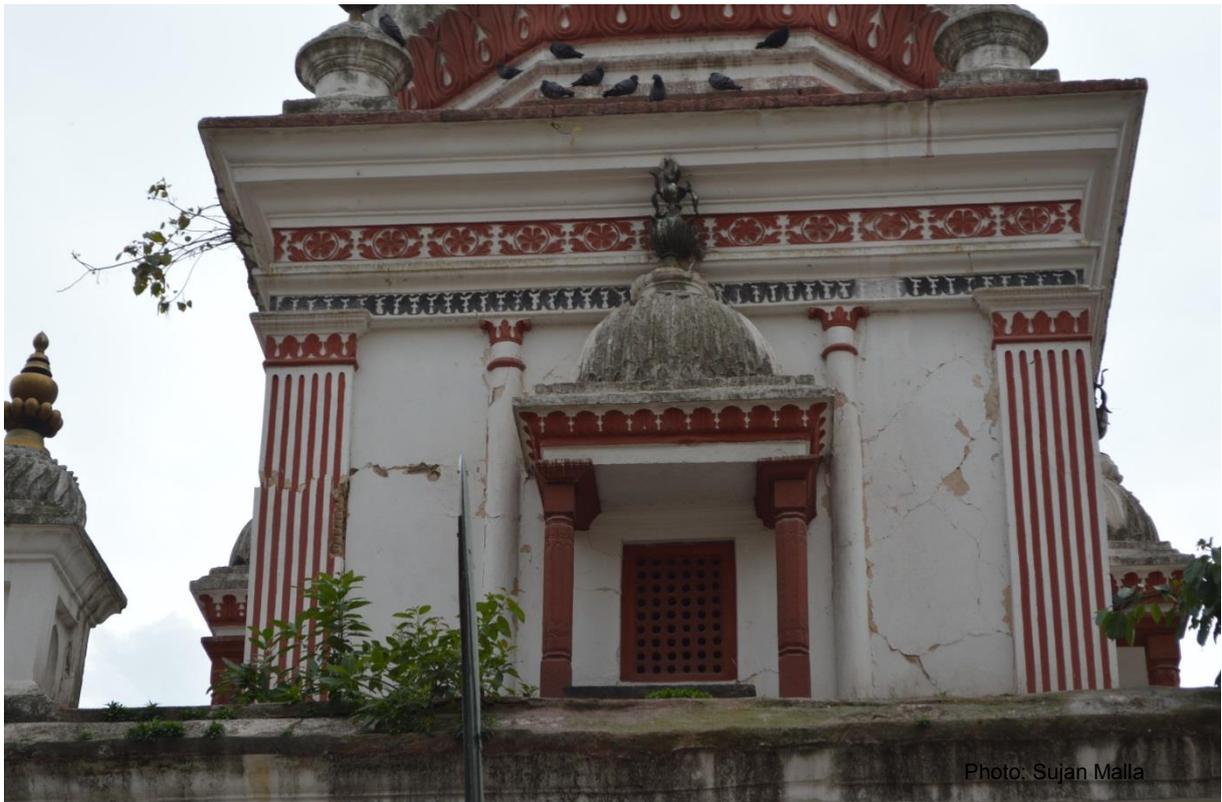
Photo 15 Temples in Kathmandu with significant cracks

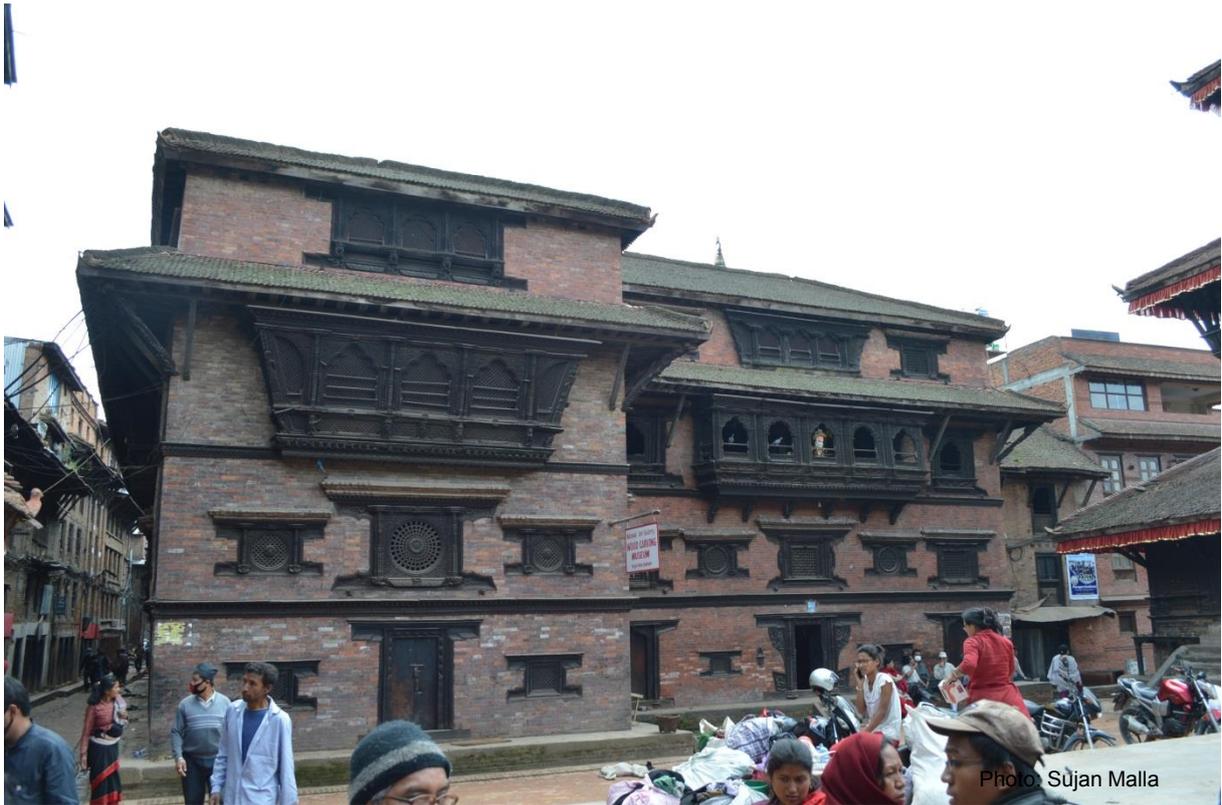
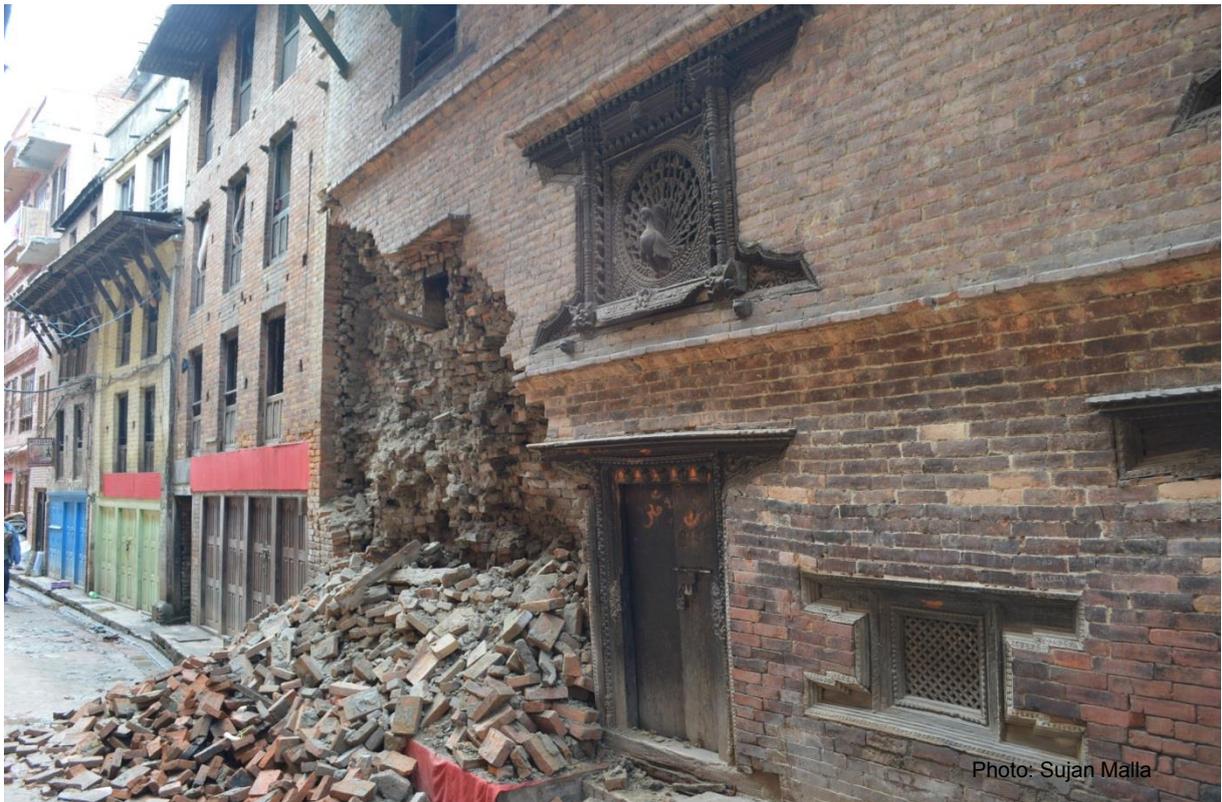
Photo 16 Pujari Math in Bhaktapur with partial wall collapse

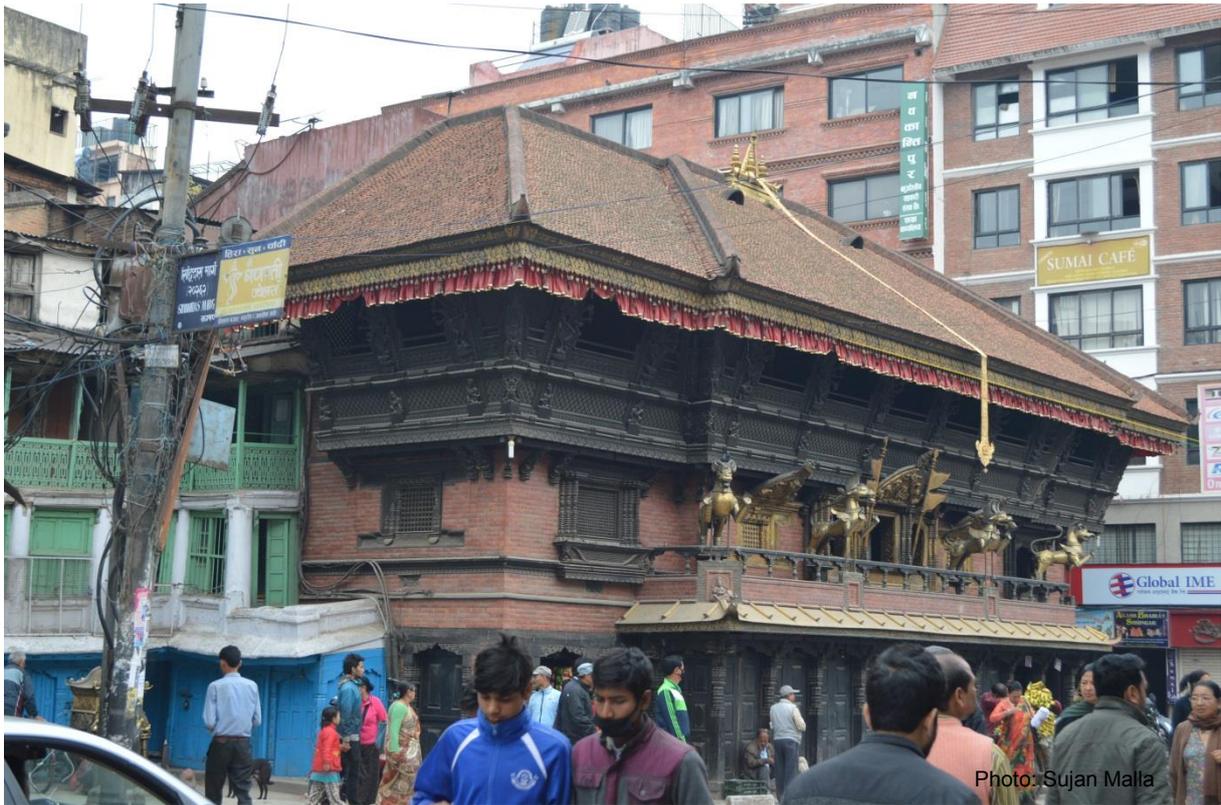
Photo 17 Akash Bhairav temple at Indrachowk, Kathmandu with no externally visible damage

It is interesting to note that some old temples that have survived the 2015 earthquake are also known to be those that suffered the least damage in the 1934 earthquake disaster, for example the Akash Bhairav Temple (Photo 17) at Indrachowk, Kathmandu, the Pashupatinath Temple in Kathmandu and the Nyatapole Temple (Photo 12) at the Taumadhi Square, Bhaktapur (Shakya, 2000). In the Nyatapole Temple, the highest pagoda temple in Nepal, only the uppermost storey shows externally visible damage, which seems to be a re-run of the 1934 earthquake damage to this temple, as recalled by some elderly people in Bhaktapur. An investigation of the possible reasons (e.g. more robust structural system, better maintenance, etc.) for the apparent earthquake resilience of these temples could provide valuable hints for the earthquake-resistant redesign of the collapsed temples.

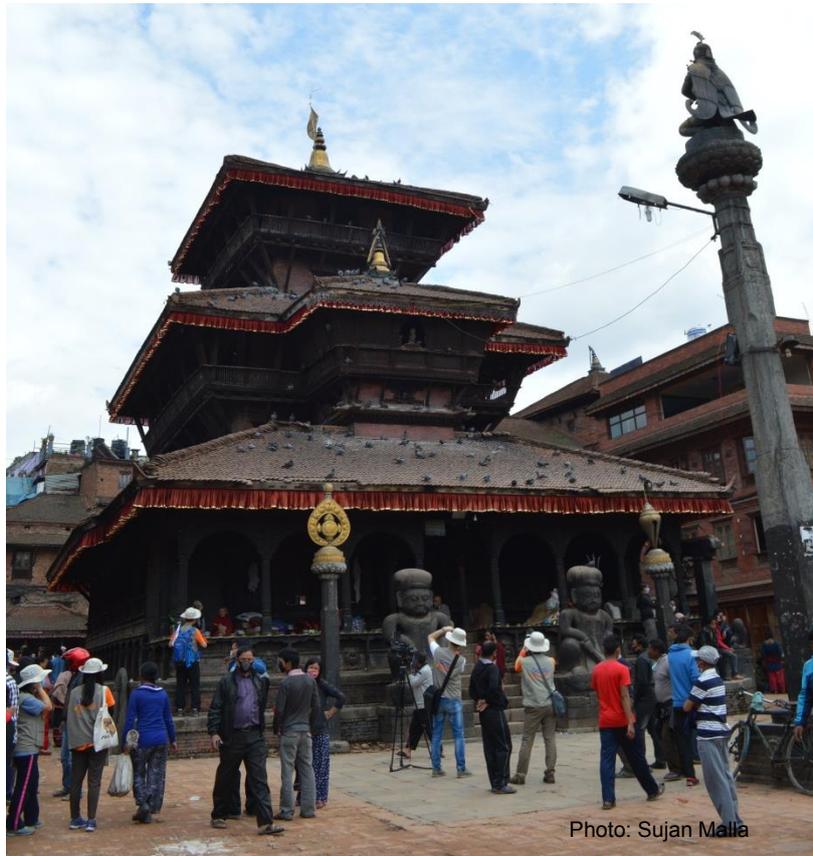
Photo 18 Dattatreya temple in Bhaktapur with no externally visible damage

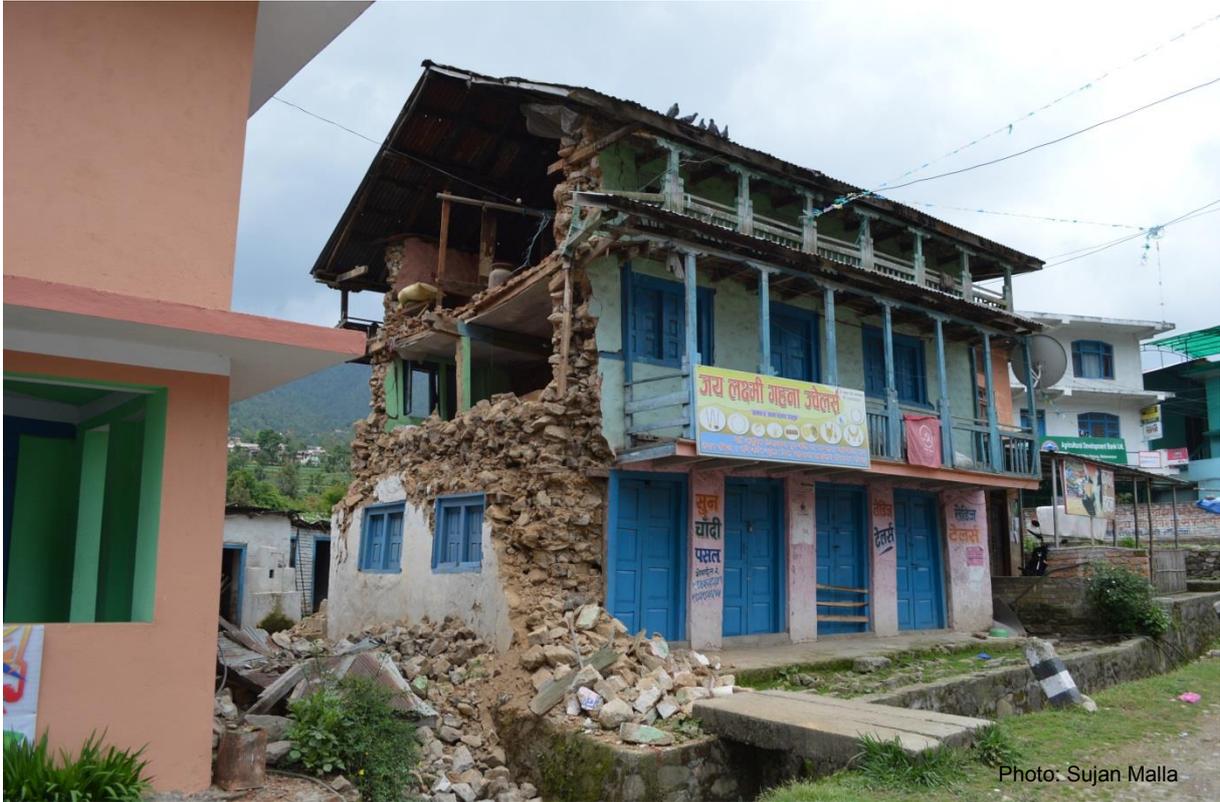
Photo 19 Stone rubble masonry building with end wall collapse along Tribhuvan highway

In the mountainous regions of Nepal, a majority of people live in houses made of stone rubble masonry held together with mud mortar. Such structures are inherently vulnerable to sudden brittle failure when subjected to strong earthquake shaking (see Photo 19 and Photo 20).

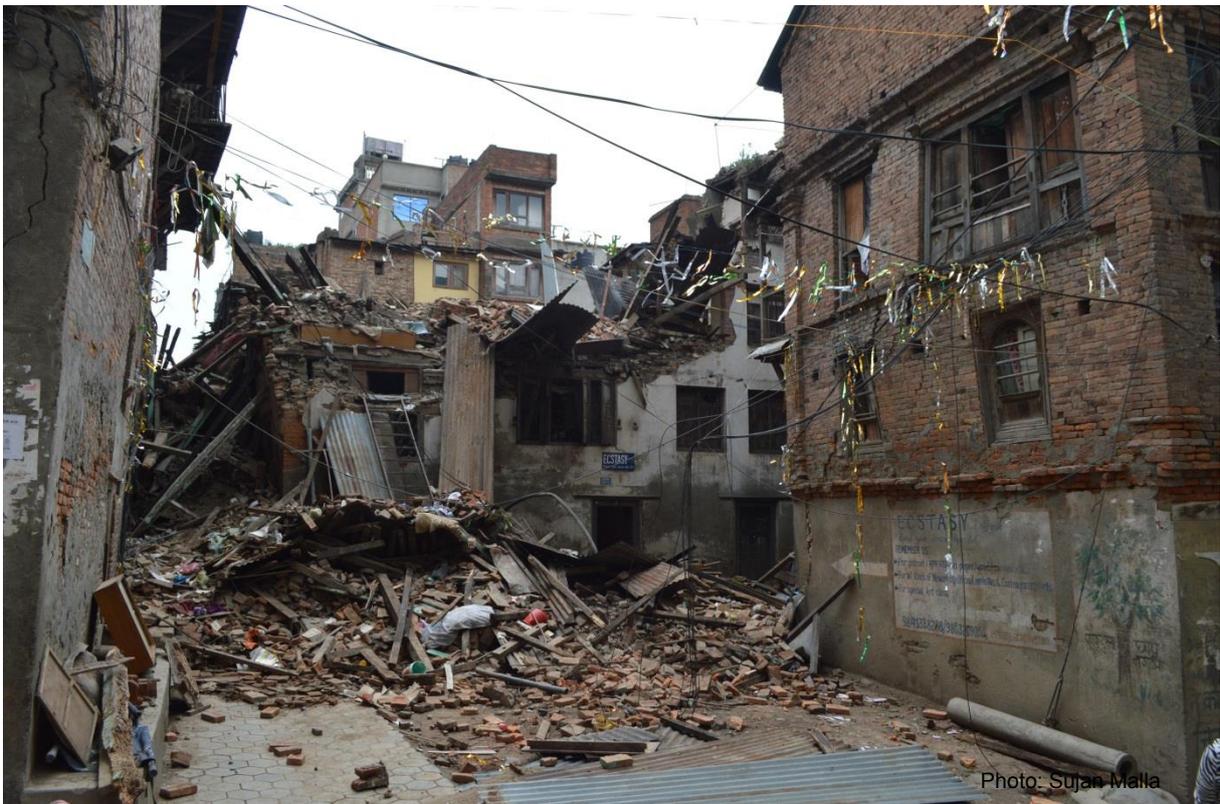
Photo 22 Partially collapsed brick masonry building in Kathmandu

A majority of buildings in the old towns and villages in the Kathmandu Valley are made of brick masonry held together by mud mortar. Such buildings are also vulnerable to earthquake damage, although somewhat less than the stone rubble masonry buildings. Many brick buildings also collapsed due to the ground shaking caused by the 2015 earthquake (see Photo 21 to Photo 29).

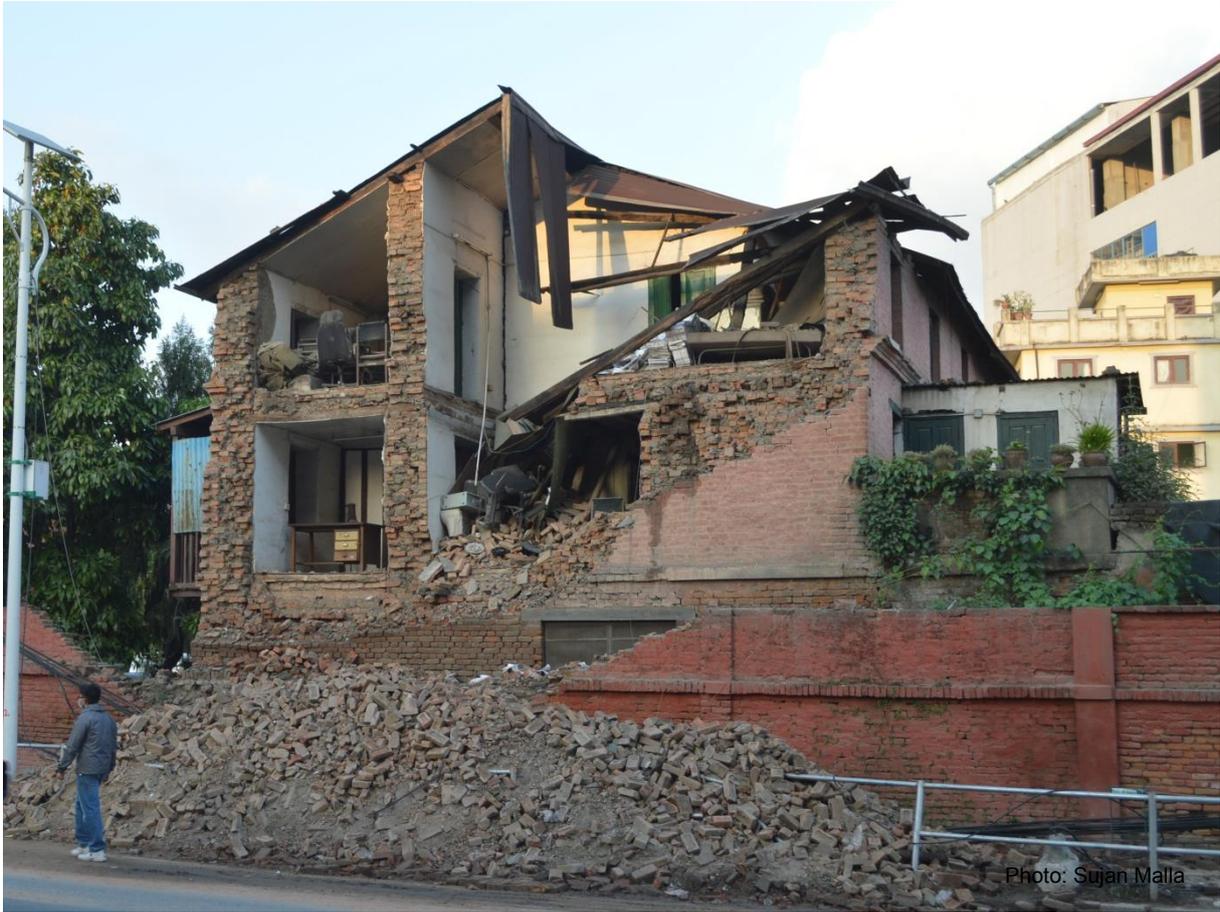
Photo 28 Collapsed gable wall of a brick masonry building at Jamal in Kathmandu
