LESSONS OF 2015 NEPAL EARTHQUAKE DISASTER

A Short Report on Effects of
7.8 M_w Earthquake of 25 April 2015 and Its Aftershocks
(Including Photo Documentation)

Sujan Malla, Dr. Eng.

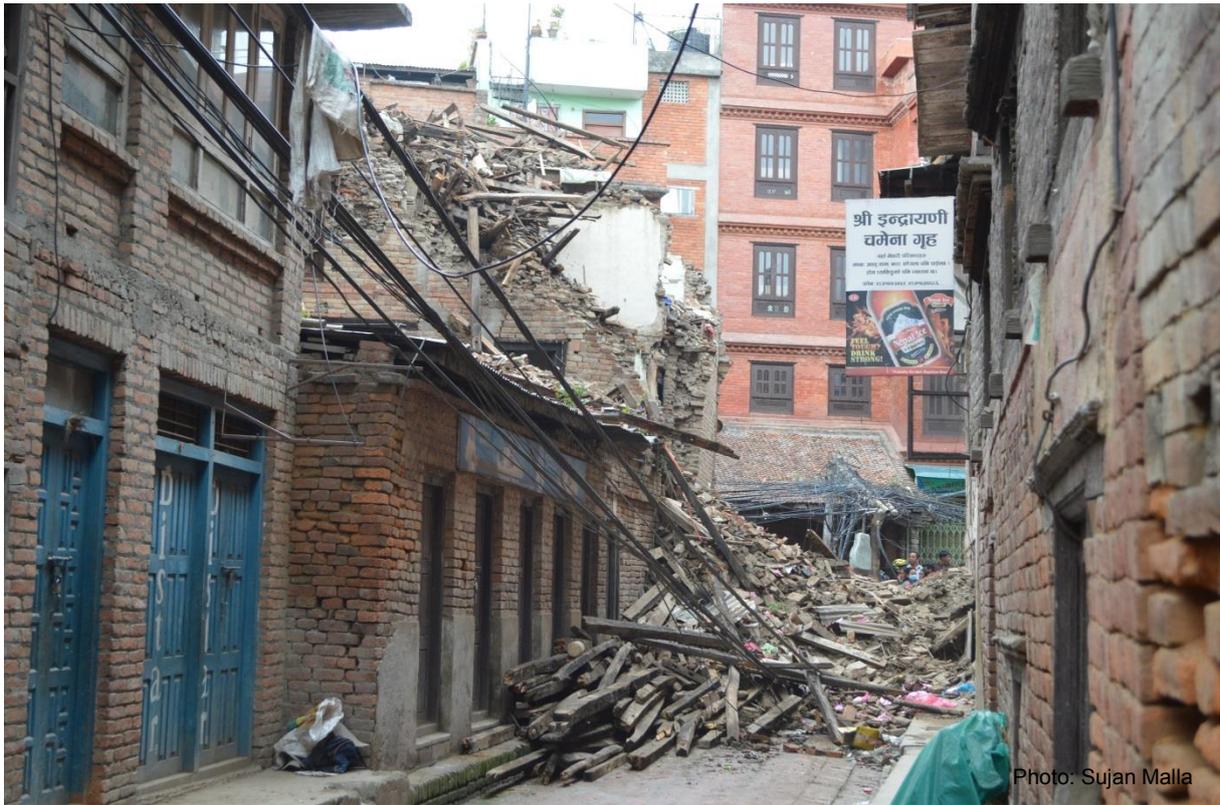
Photo 29 Narrow alleys blocked by collapsed buildings in Bhaktapur

A majority of buildings in the old towns and villages in the Kathmandu Valley are made of brick masonry held together by mud mortar. Such buildings are also vulnerable to earthquake damage, although somewhat less than the stone rubble masonry buildings. Many brick buildings also collapsed due to the ground shaking caused by the 2015 earthquake (see Photo 21 to Photo 29).

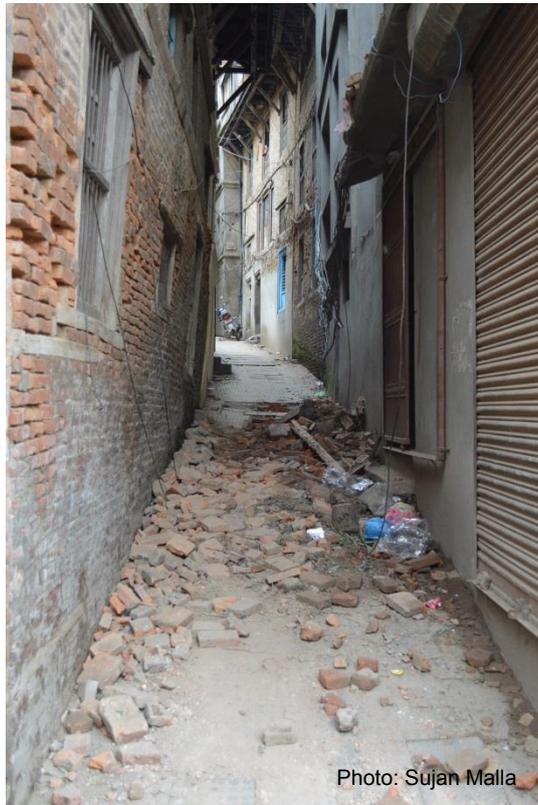
Photo 31 Hazard posed by dropping bricks in a narrow alley in Kathmandu

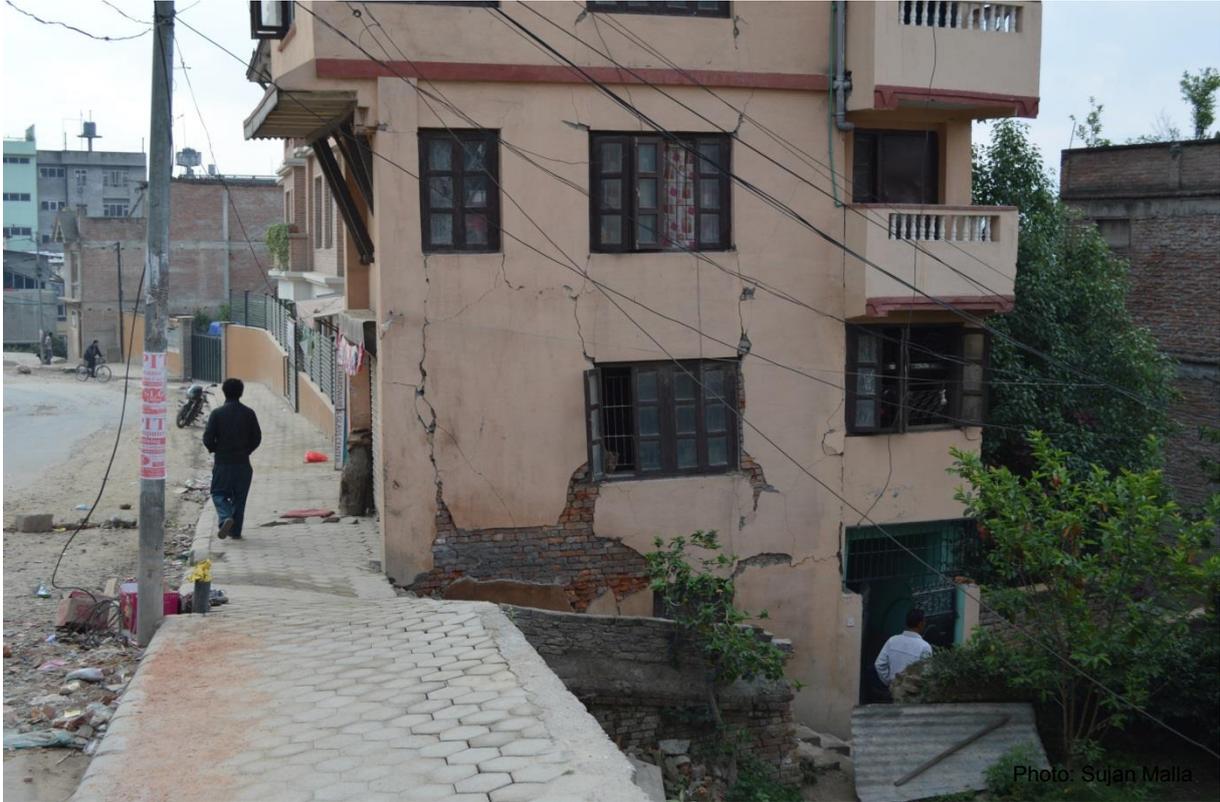
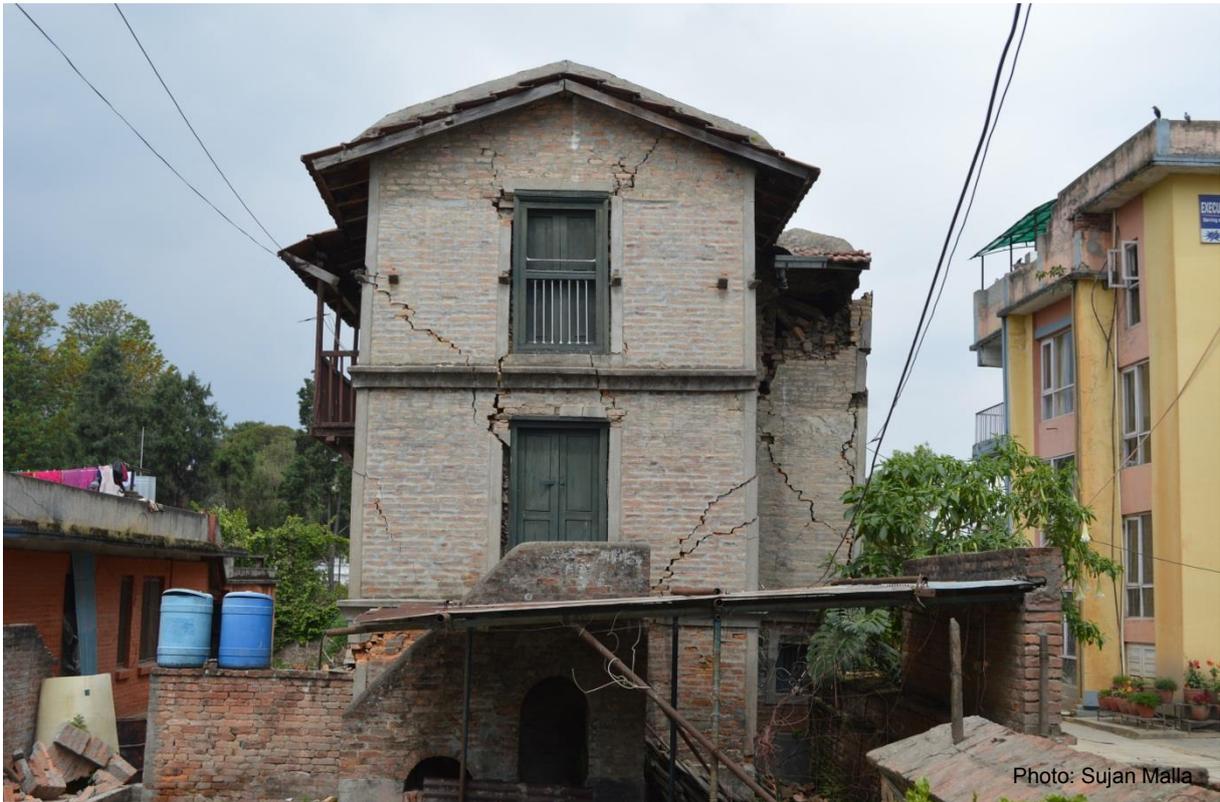
Photo 34 Brick masonry buildings with major cracks caused by earthquake shaking

A great majority of such old brick buildings in the Kathmandu Valley (probably more than about 90%) surprisingly did not collapse during such a strong earthquake with a magnitude of 7.8 M_w . However, many have suffered various degrees of damage (see Photo 34 to Photo 37). Among the three largest old towns of Kathmandu, Patan and Bhaktapur, the percentage of collapsed brick buildings appears to be the highest in Bhaktapur. In some smaller towns

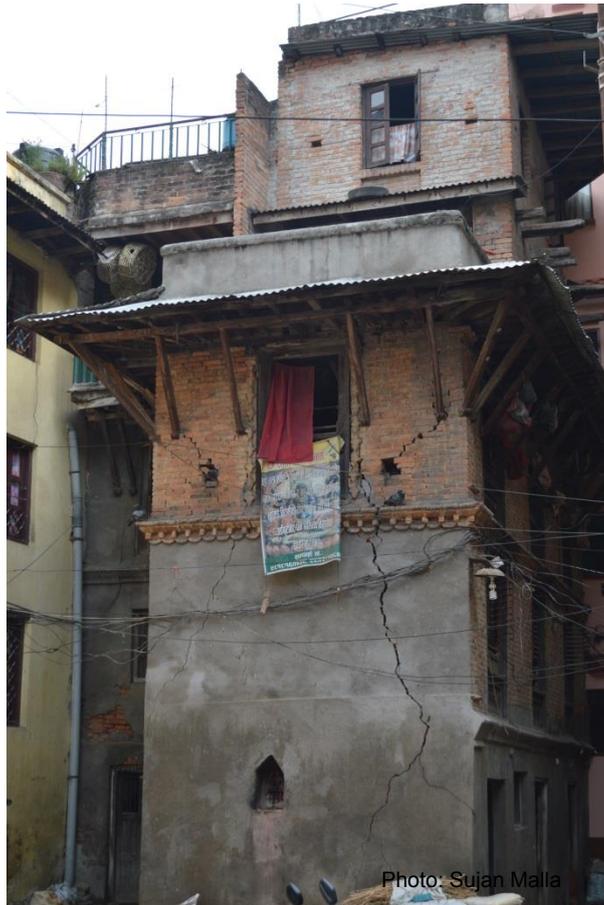
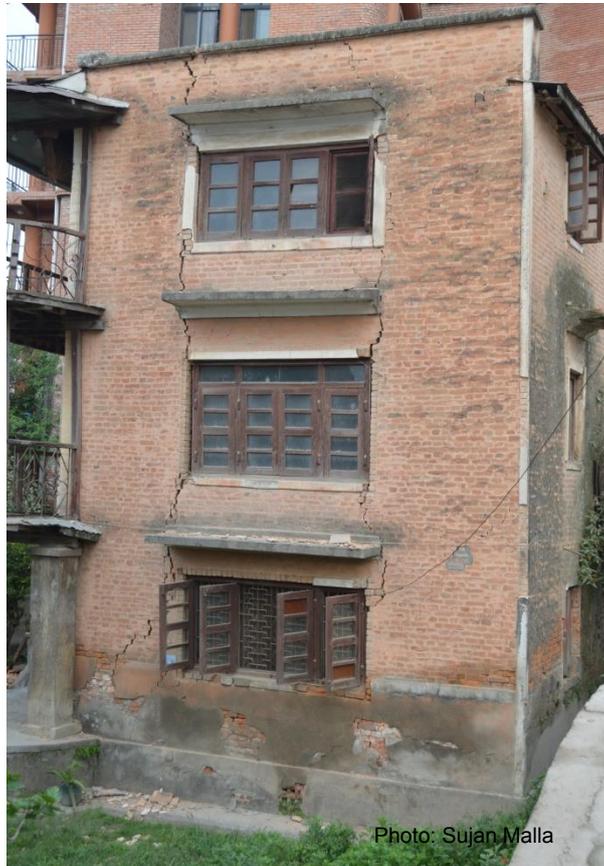
Photo 35 Brick masonry buildings in Kathmandu with major cracks caused by earthquake shaking

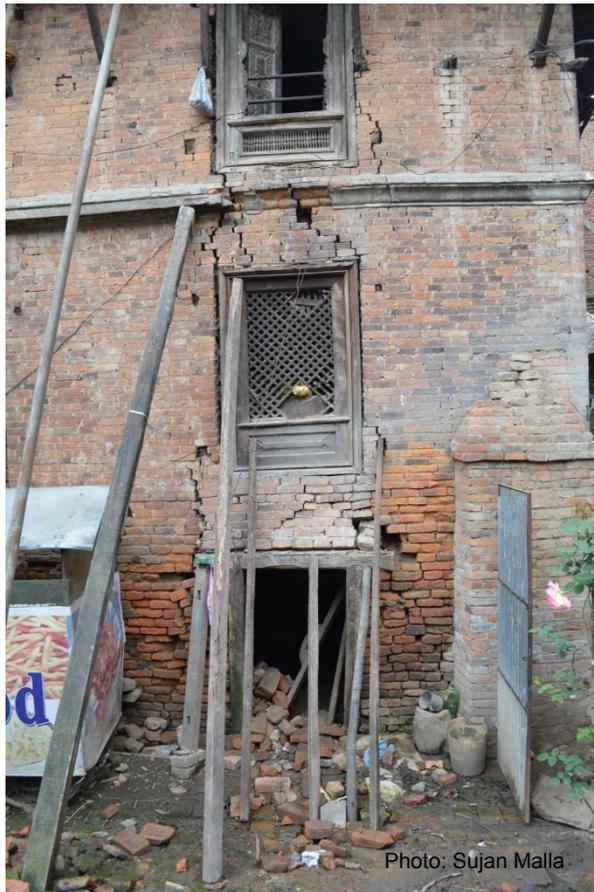
Photo 36 Brick masonry building in Bhaktapur with major cracks

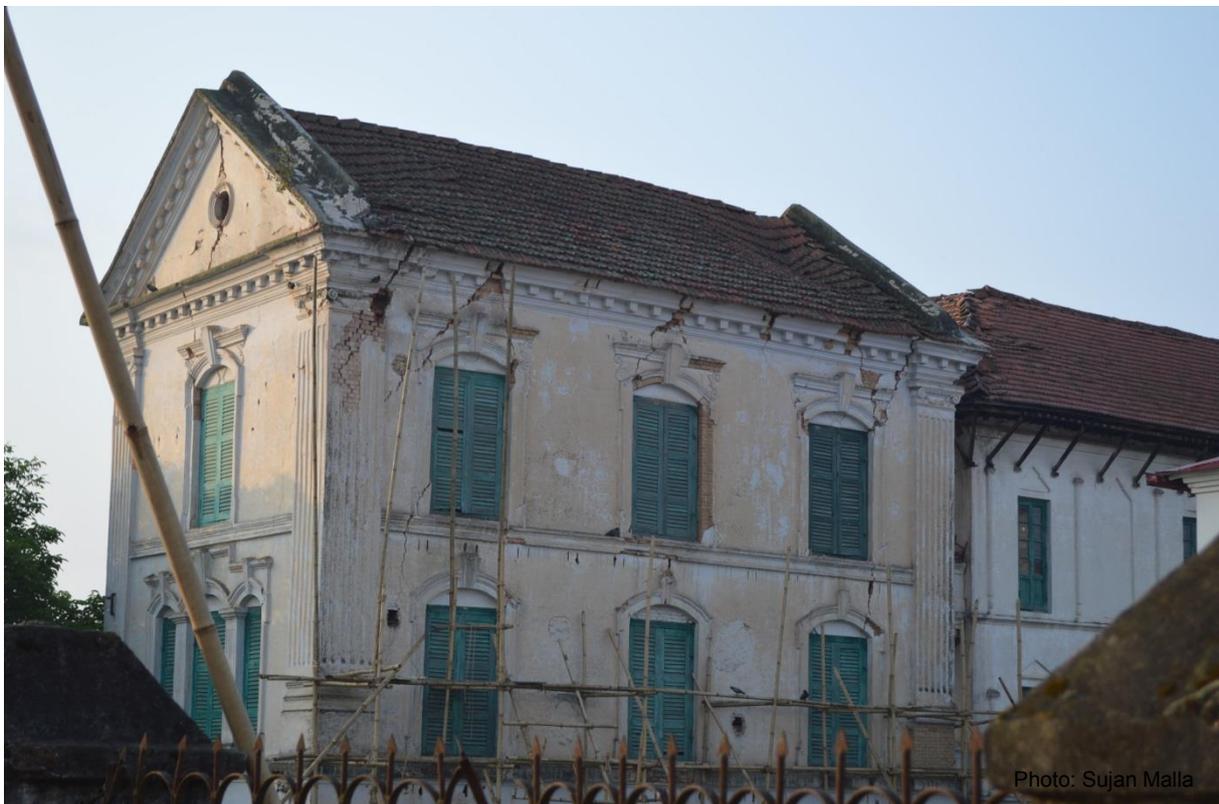
Photo 37 A building of National Museum at Chhauni, Kathmandu with severe cracks

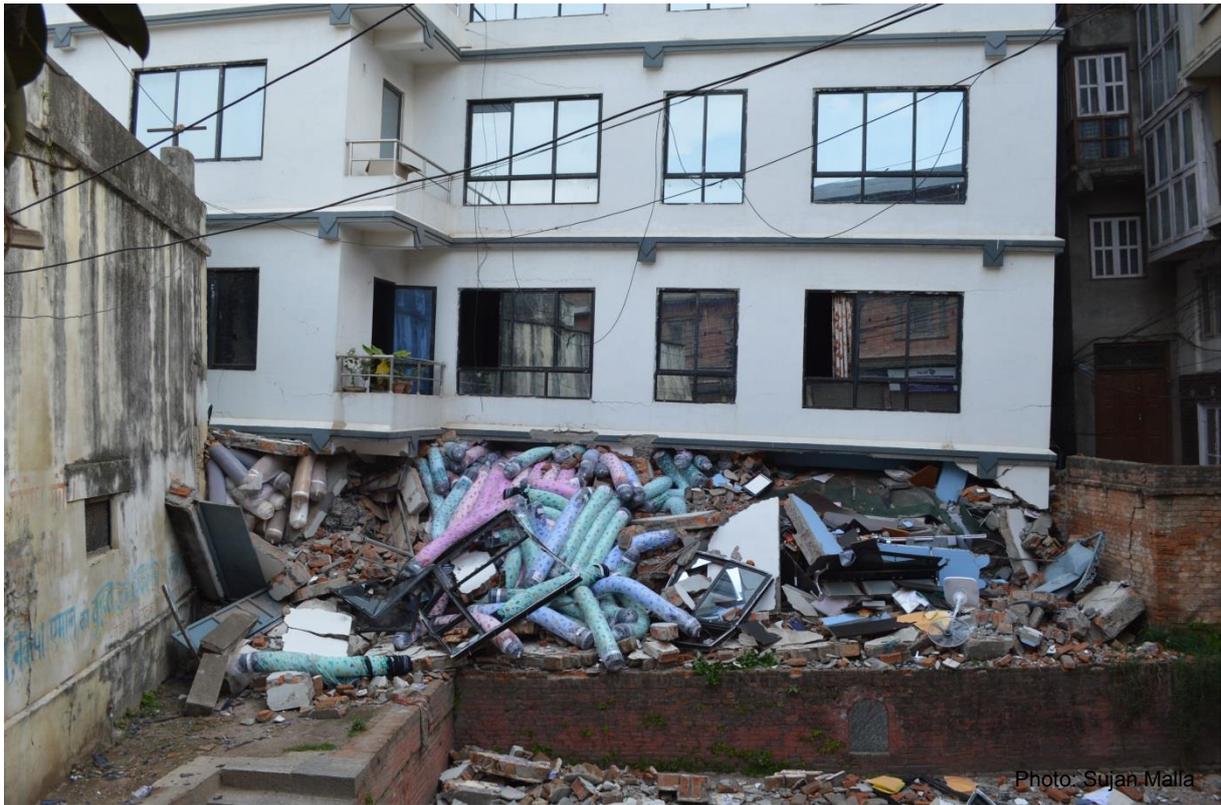
Photo 38 Soft-storey failure of a reinforced concrete frame building at Paropakar Marg, Kathmandu

The reinforced concrete (RC) structures were built in Nepal in many cases without performing proper structural analysis and design by a qualified structural engineer. Even when a structural analysis was carried out, more often than not the earthquake load considered in the design was too low, usually not more than about 0.1 g. Poor concrete quality and deficient reinforcement detailing are further factors that make the reinforced concrete structures in Nepal vulnerable to earthquake damage.

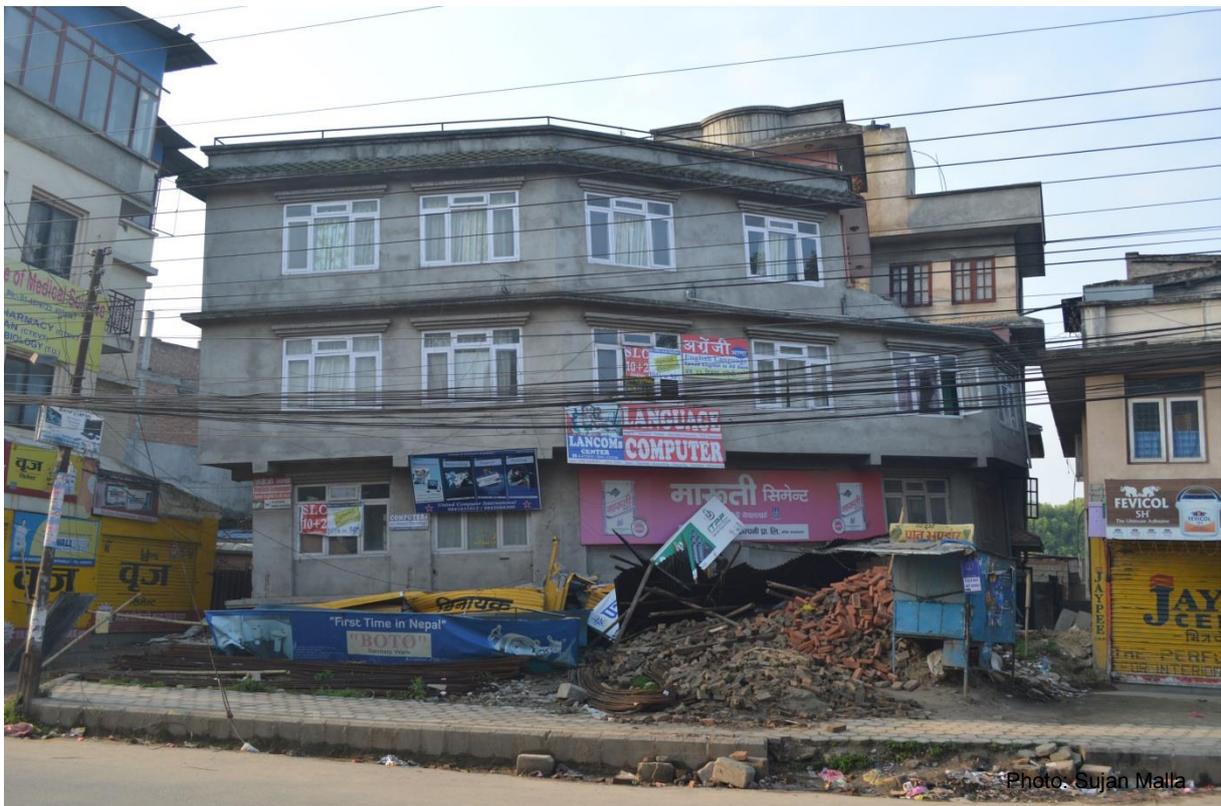
Photo 39 Soft-storey failure of a reinforced concrete frame structure at Sitapaila in Kathmandu

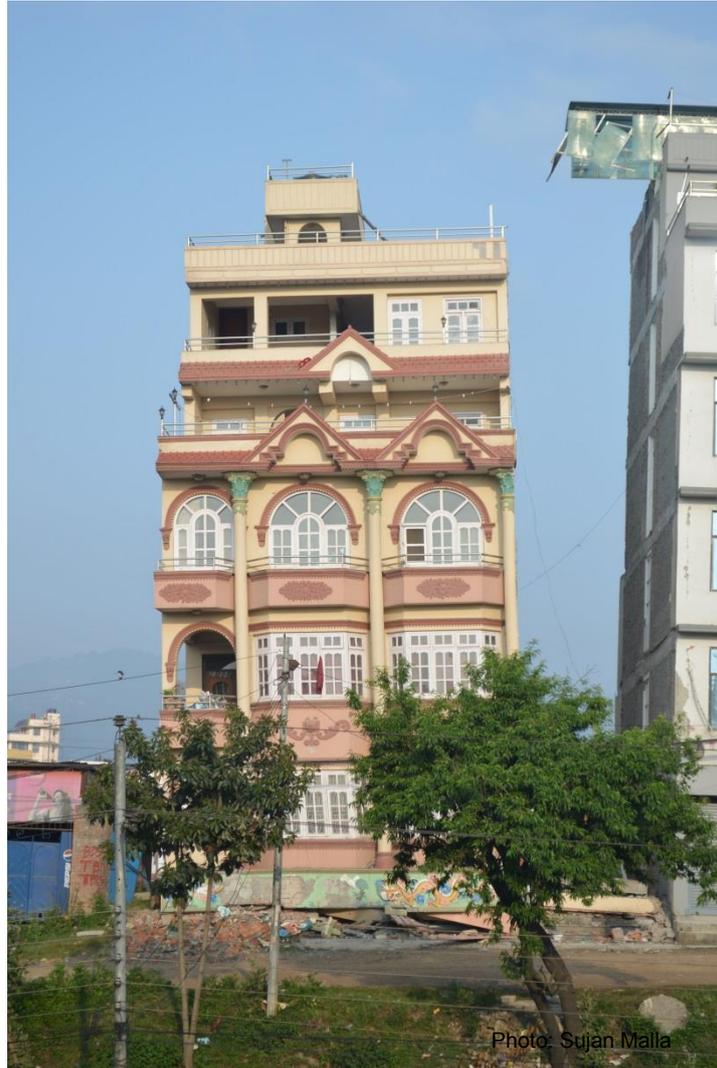
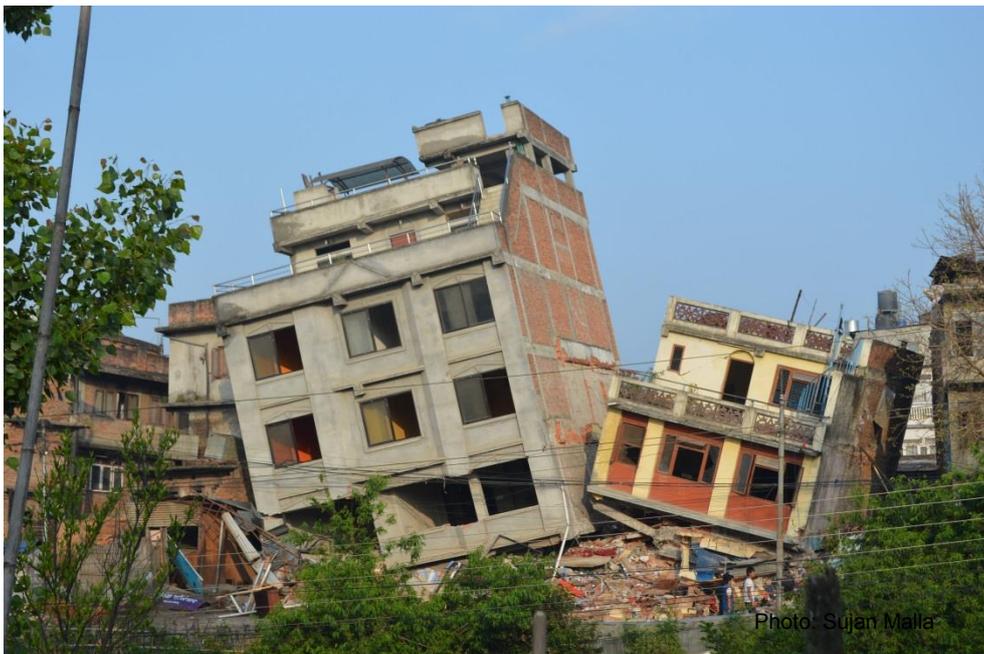
Photo 40 Soft-storey failures of reinforced concrete frame structures at Sitapaila in Kathmandu

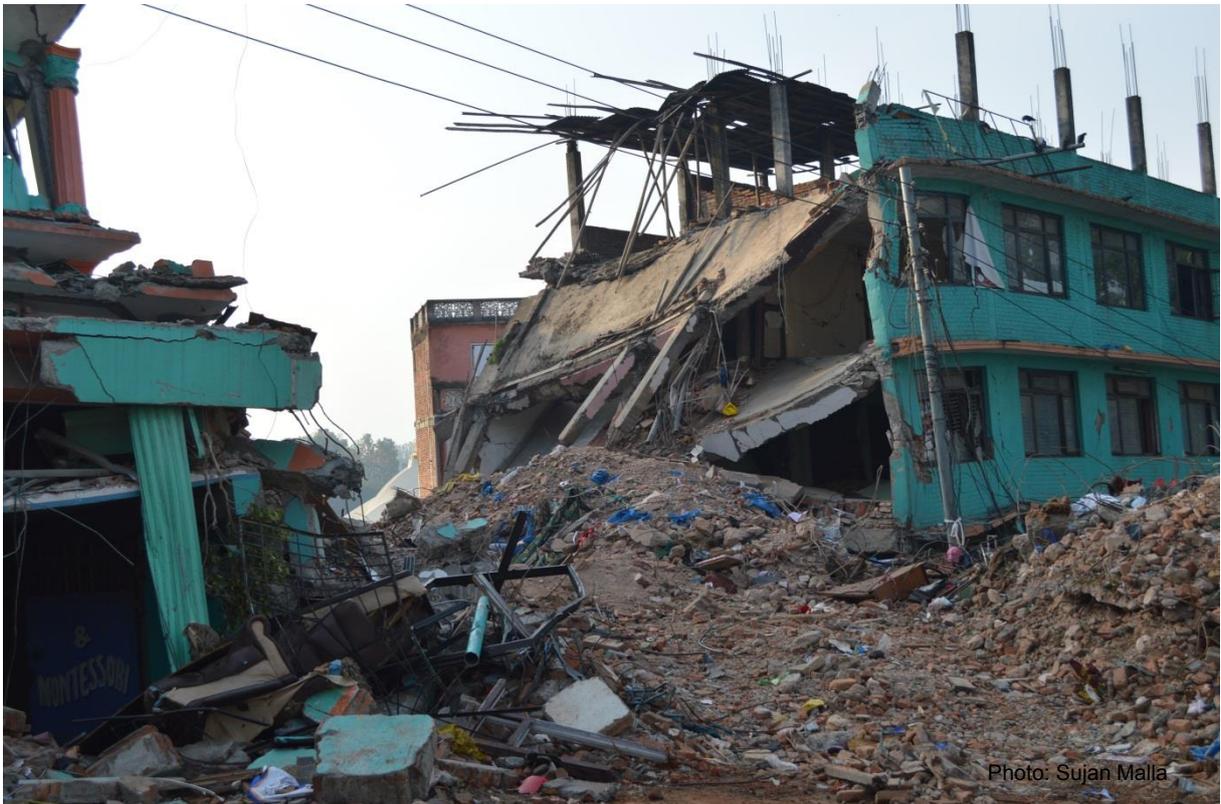
Photo 43 Collapsed reinforced concrete frame building at Sitapaila in Kathmandu

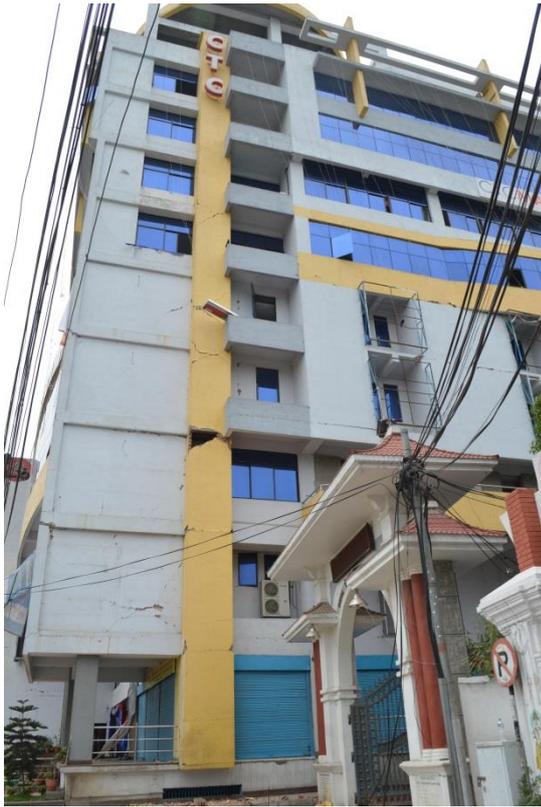
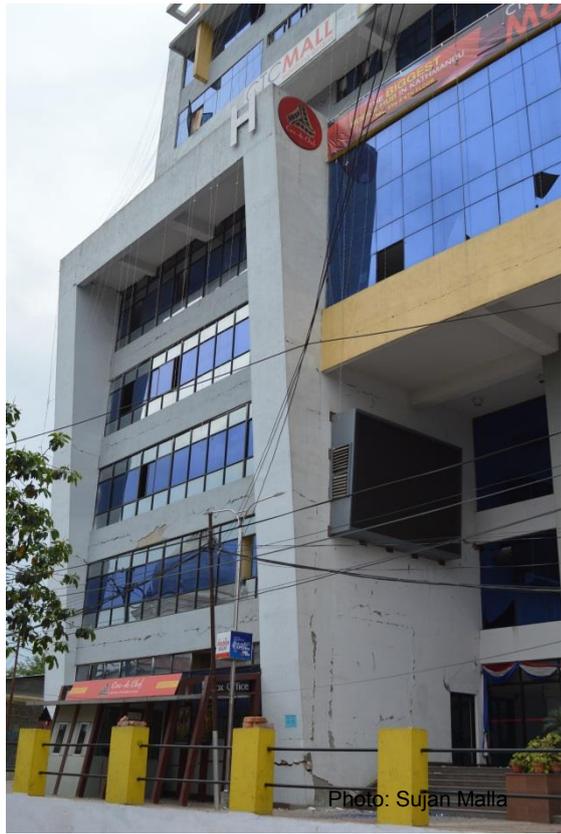
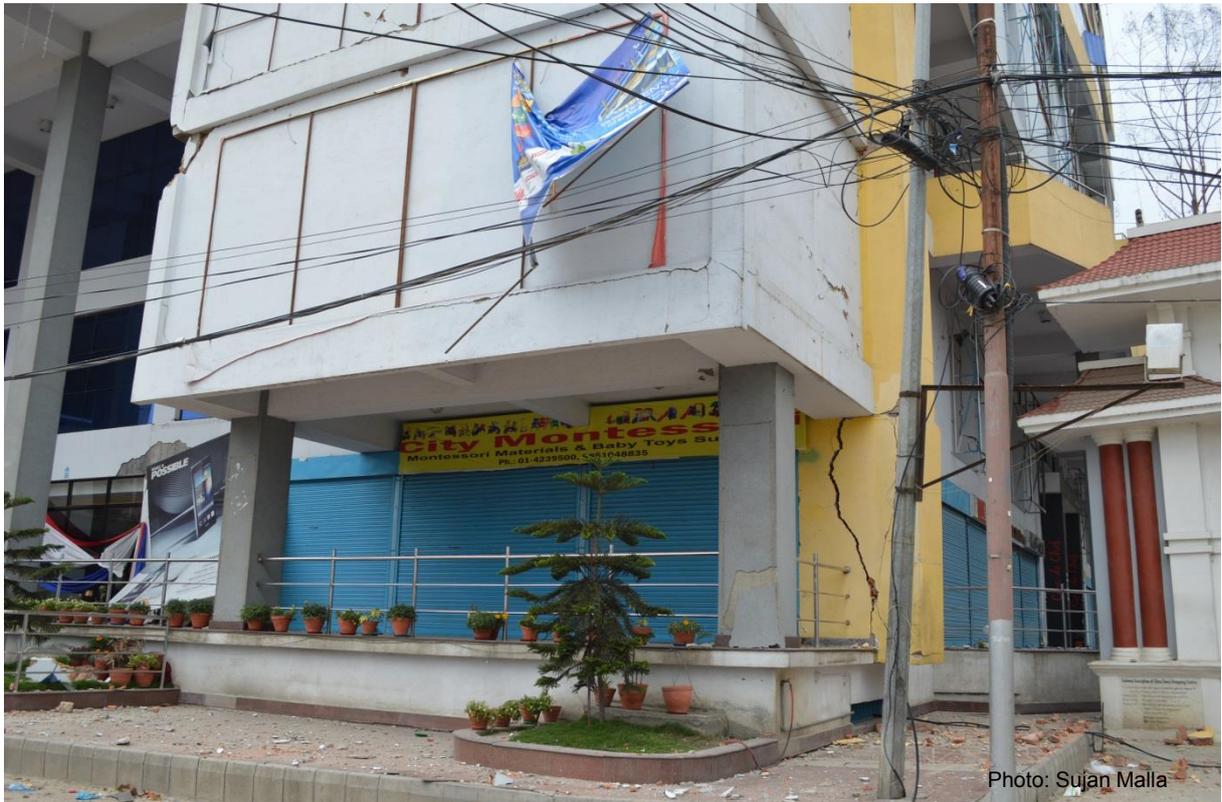
Photo 44 CTC Mall, Sundhara, Kathmandu with substantial earthquake damage

Concrete buildings are relatively new in Nepal and have been built mainly since the 1960s. Such a building consists typically of a reinforced concrete (RC) skeletal frame with brick infill walls. The performance of the RC frame buildings in the 2015 earthquake was not necessarily superior to that of well-constructed traditional brick masonry structures. Many people are surprised that quite a few of these modern-looking structures also collapsed during the earthquake shaking (see Photo 38 to Photo 43). Quite a few recently built apartment blocks and shopping malls also suffered heavy damage, leading in some cases to a total loss of substantial investments of the owners of these expensive structures (see Photo 44).

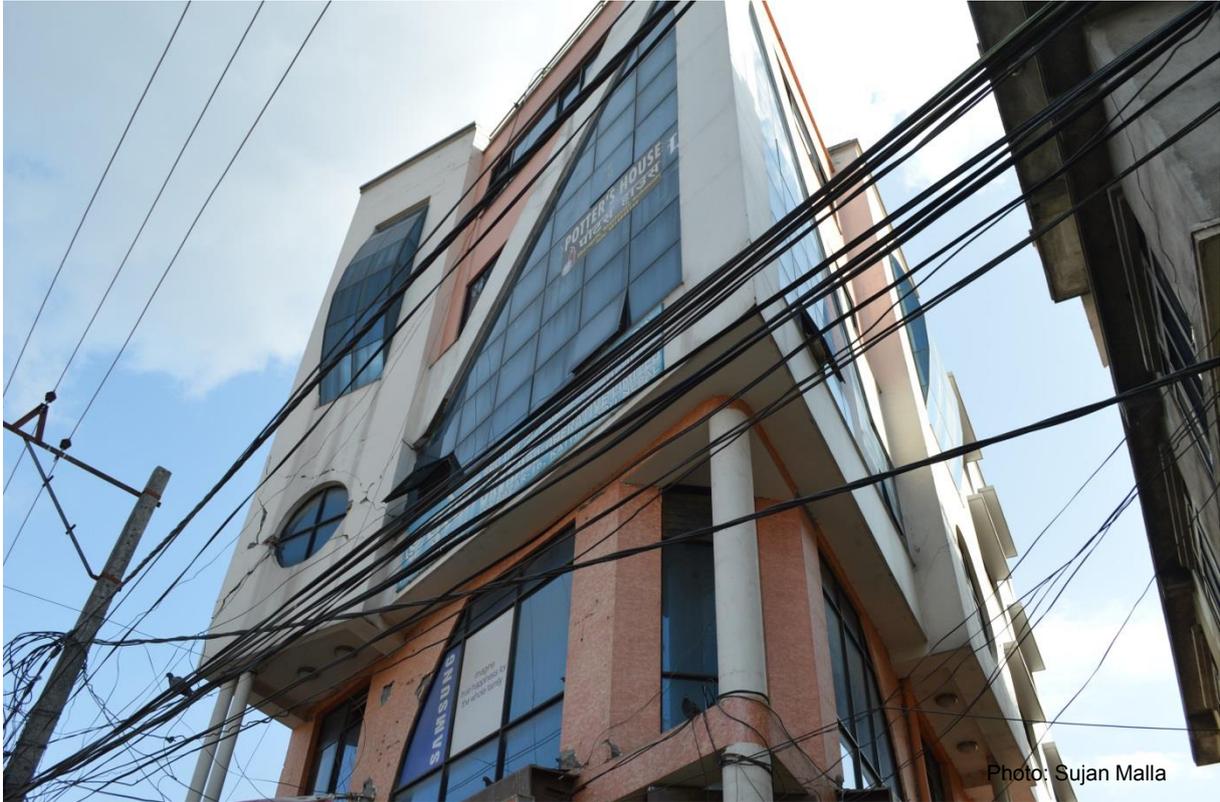
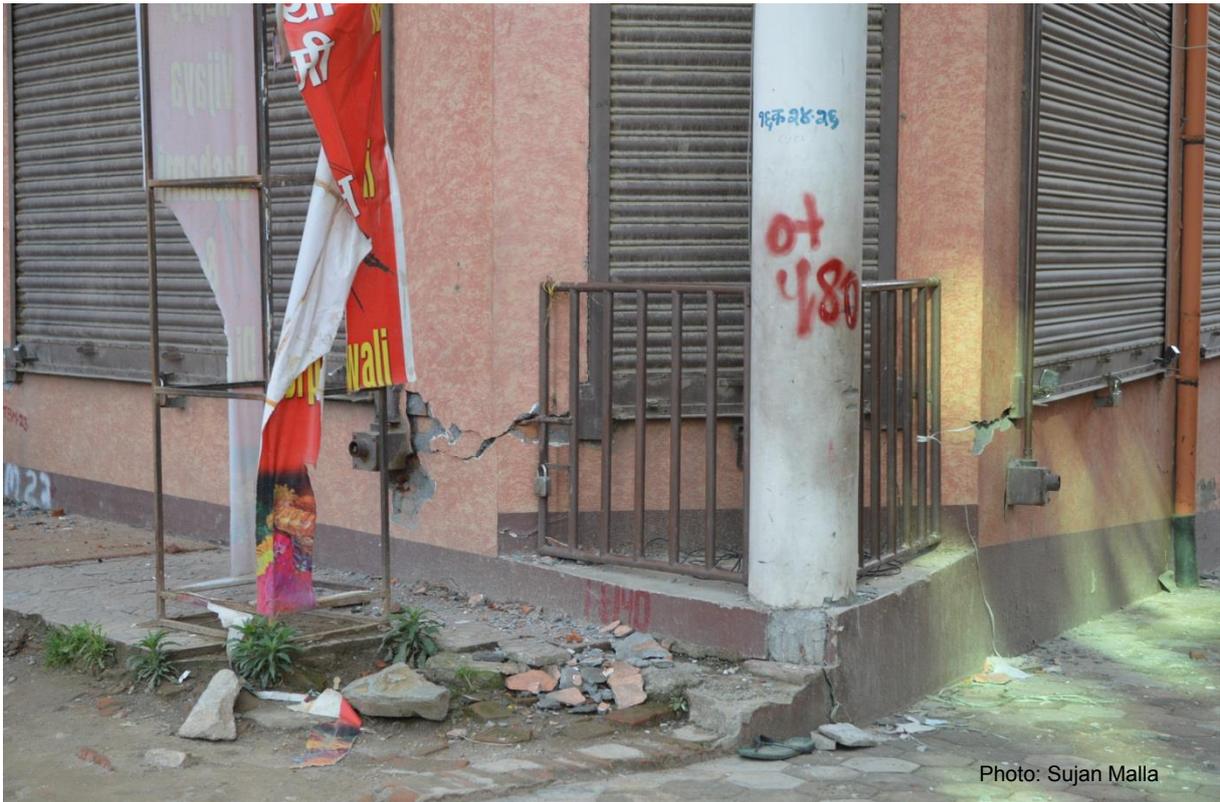
Photo 45 Seriously damaged building with complicated geometrical features

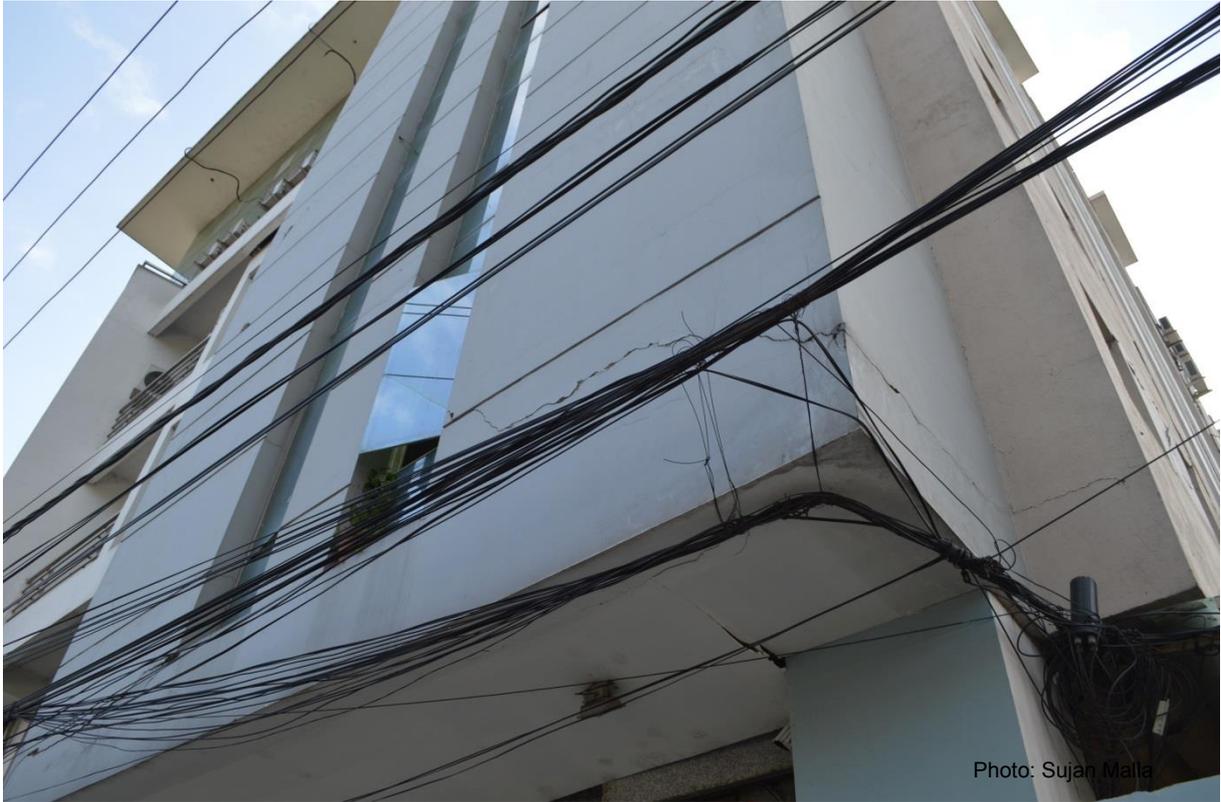
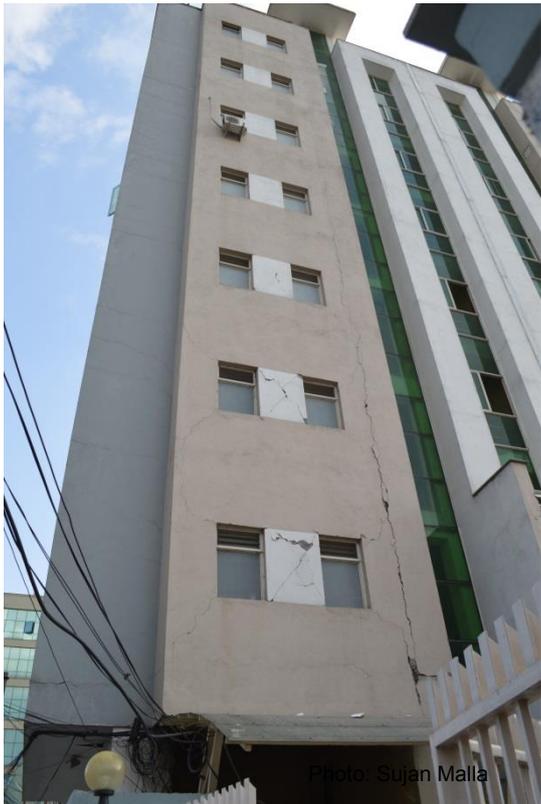
Photo 46 Office building which is no longer useable due to significant damage

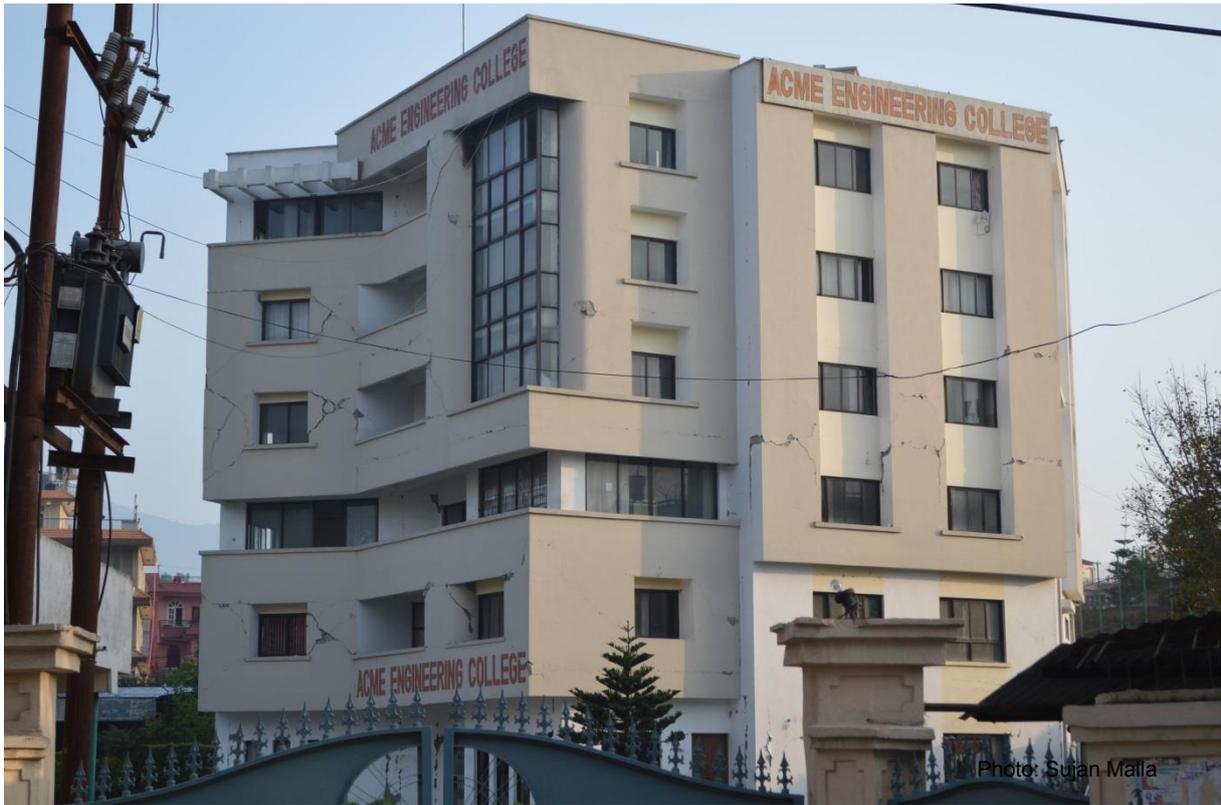
Photo 47 Significantly damaged building of Acme Engineering College, Sitapaila, Kathmandu

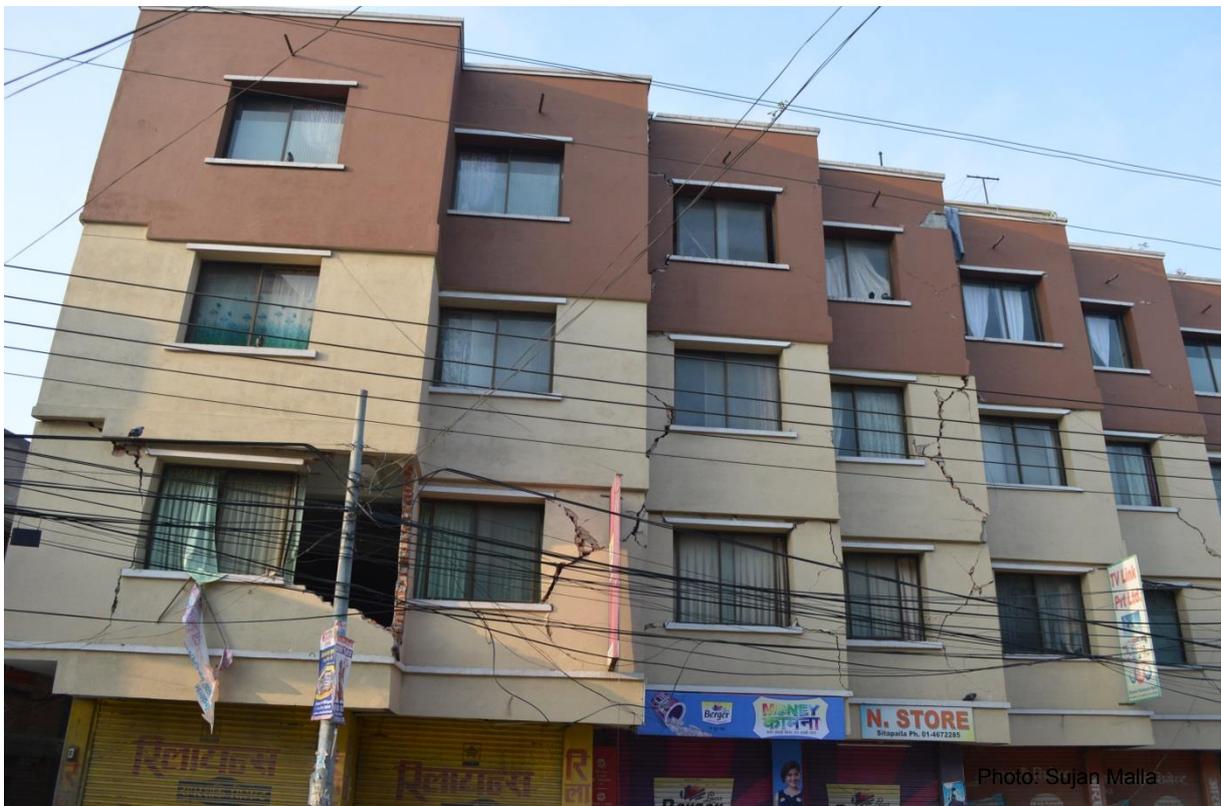
Photo 48 Heavily damaged building at Sitapaila, Kathmandu with brick infill walls of about 11 cm (half brick) thickness

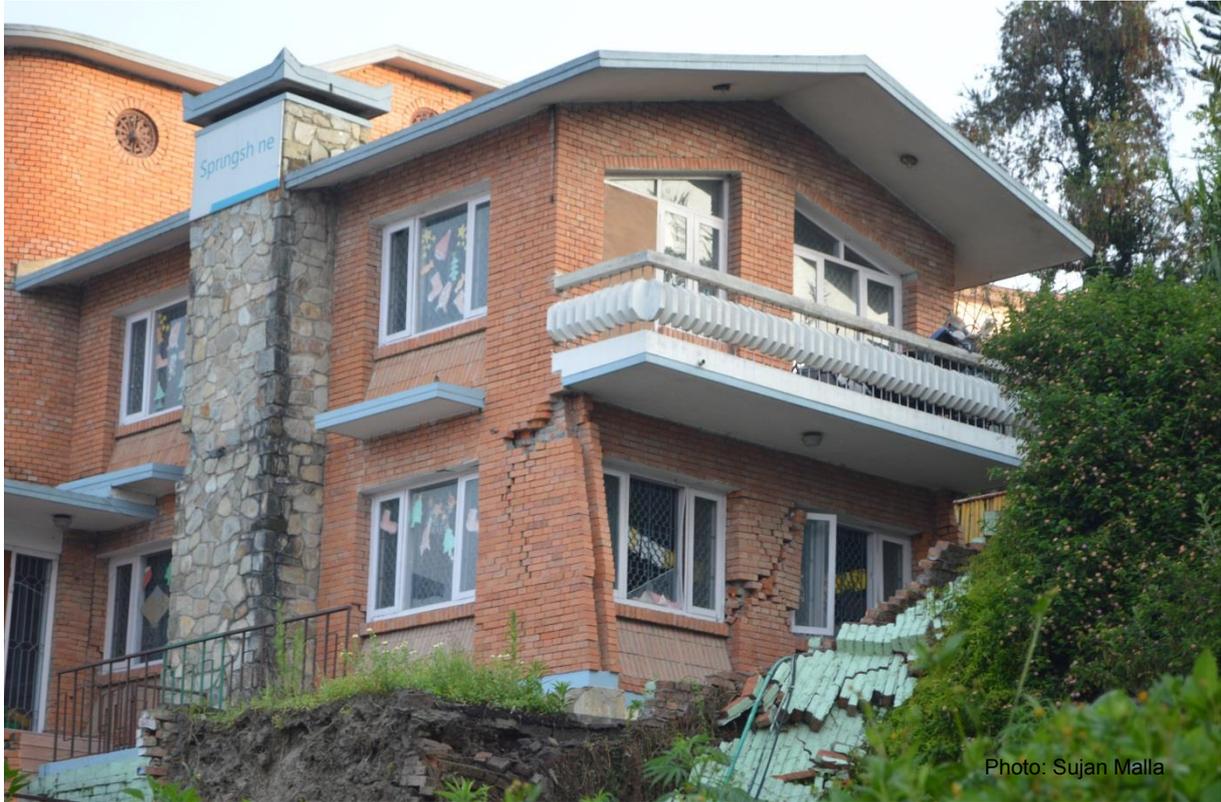
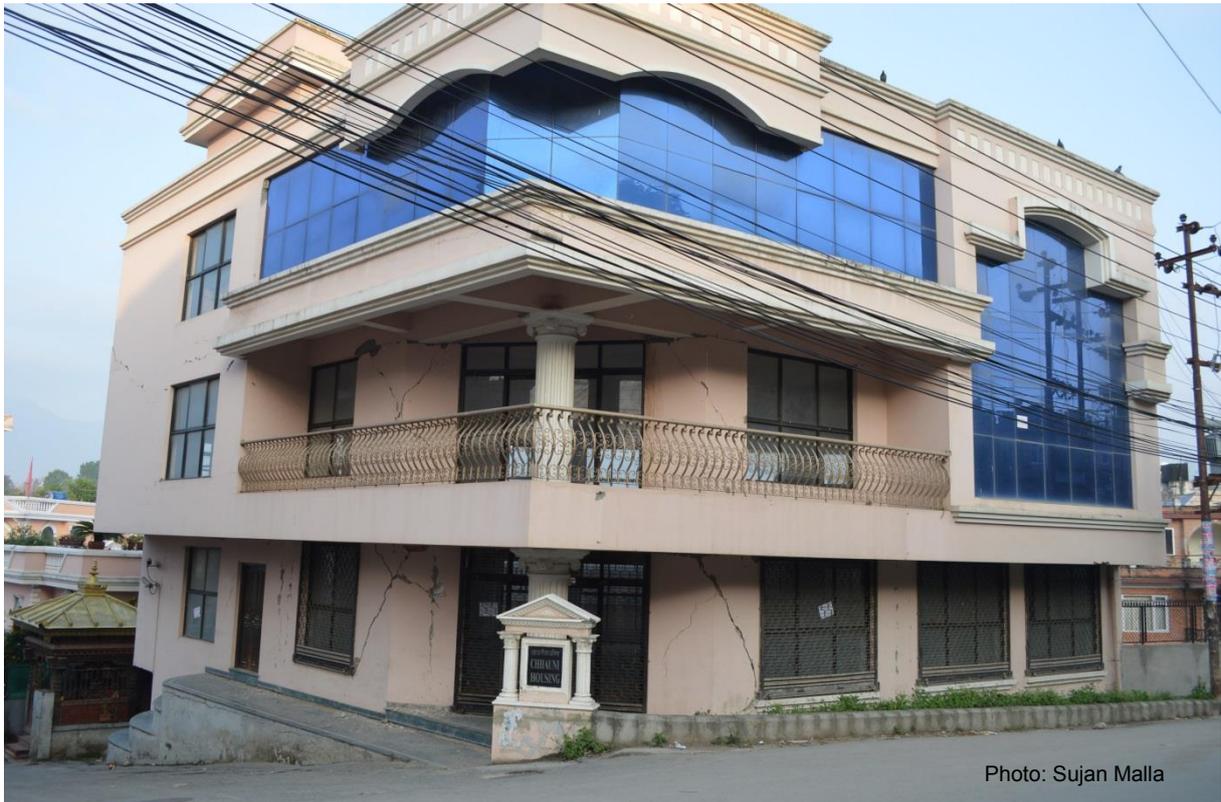
Photo 49 Residential buildings with significant cracks at Sitapaila, Kathmandu

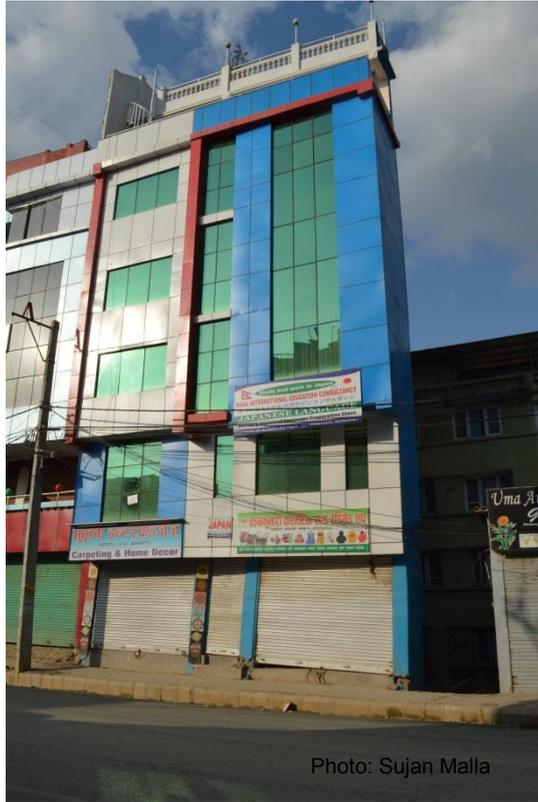
Photo 50 Building with a tilt due to earthquake damage

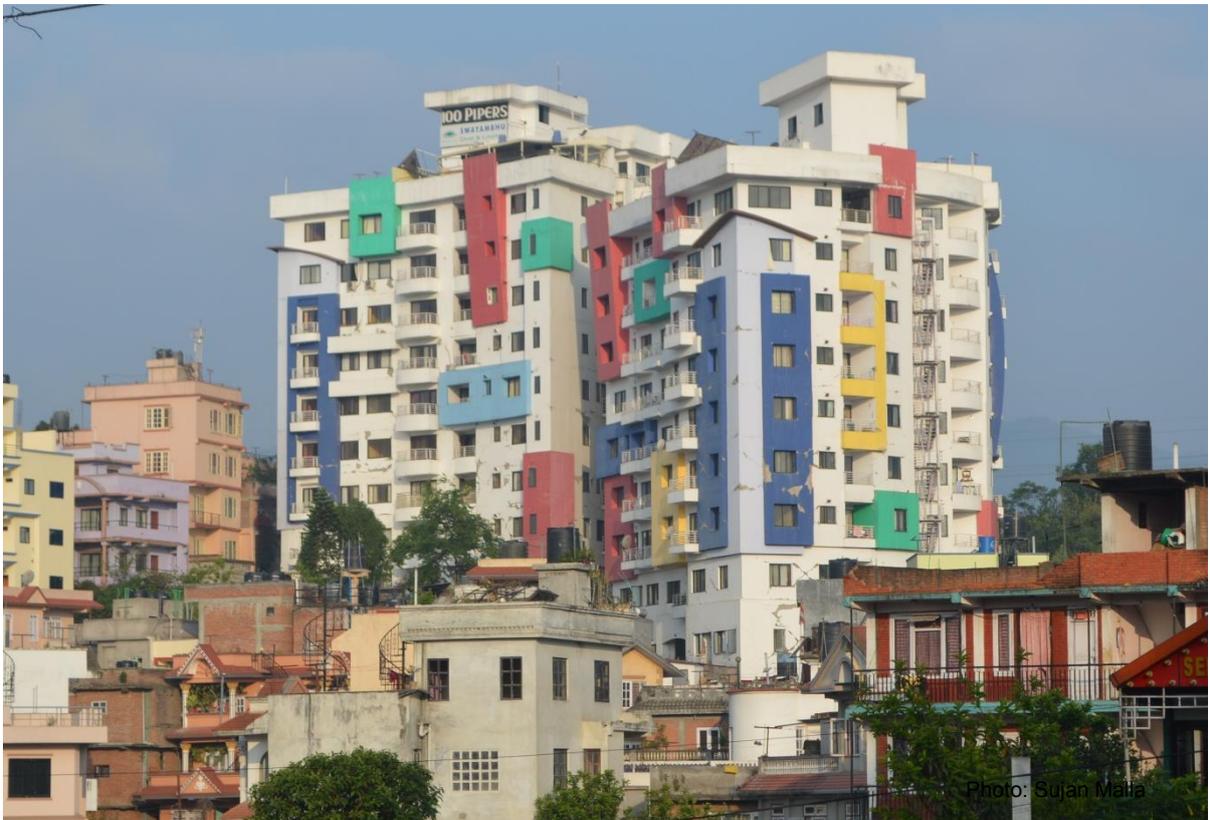
Photo 51 Multi-storeyed apartment block at Sitapaila, Kathmandu with substantial damage
