LESSONS OF 2015 NEPAL EARTHQUAKE DISASTER

A Short Report on Effects of
7.8 M_w Earthquake of 25 April 2015 and Its Aftershocks
(Including Photo Documentation)

Sujan Malla, Dr. Eng.

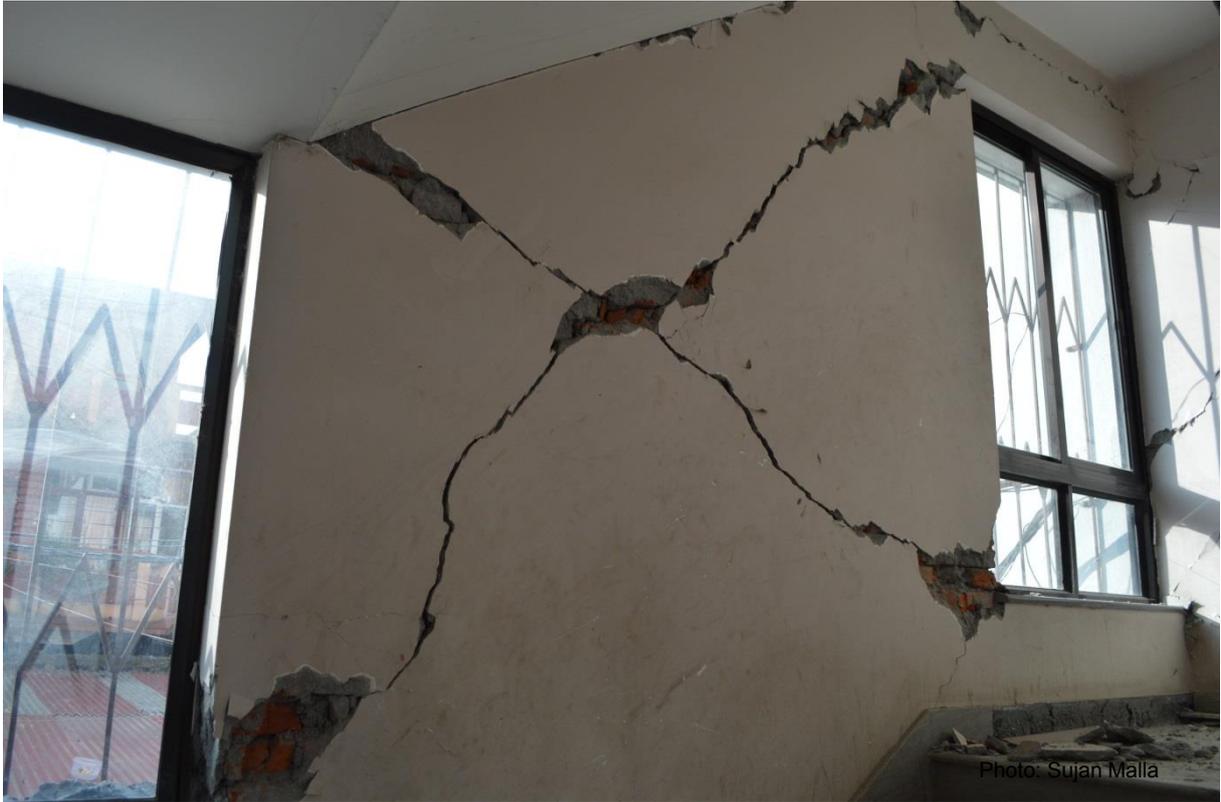
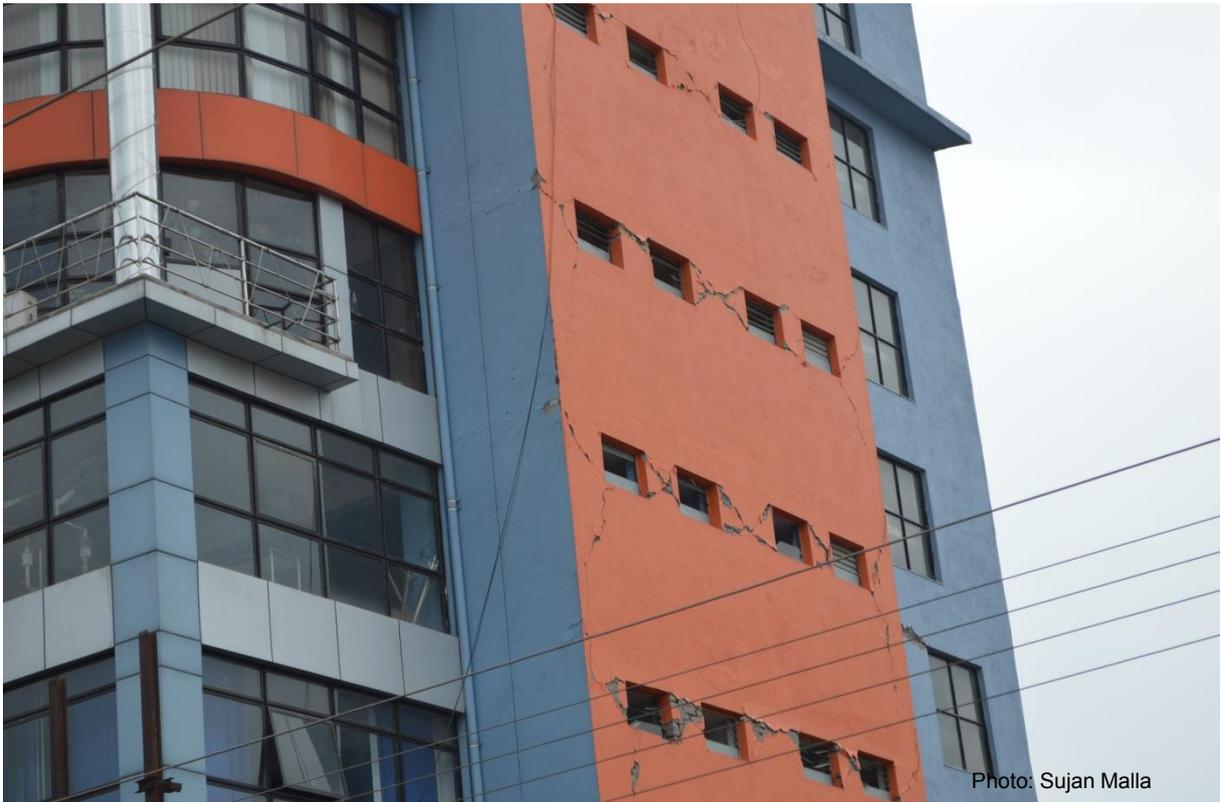
Photo 52 X-cracks in masonry infill walls of RC frame buildings

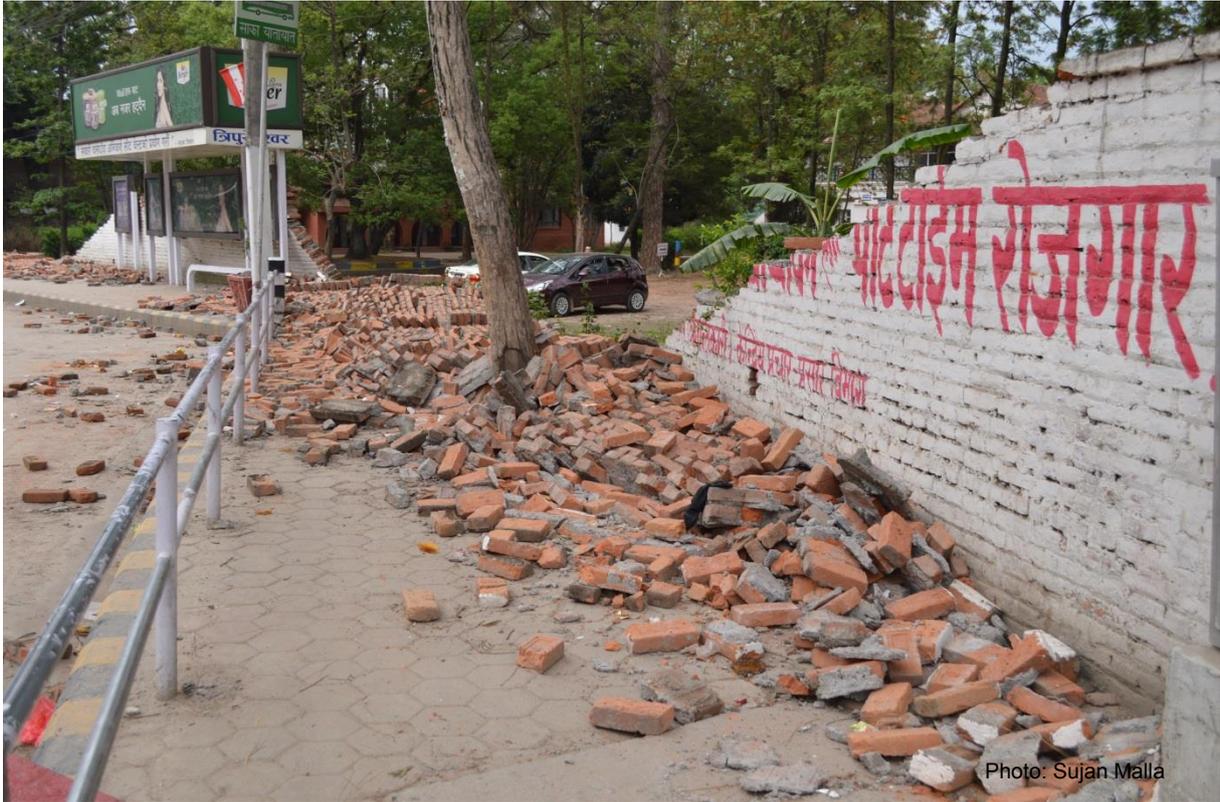
Photo 53 Boundary wall collapse blocking a sidewalk

An eye-catching feature of the 2015 Nepal earthquake is a very large number of collapsed boundary walls (see Photo 53 and Photo 54). The danger posed by possible failure and overturning of boundary walls during an earthquake is an often overlooked hazard. The building owners in Nepal typically build quite high walls around their compounds for security reasons (see Photo 55). Such walls tend to be quite slender and are mostly built of unreinforced brick masonry for economic reasons.

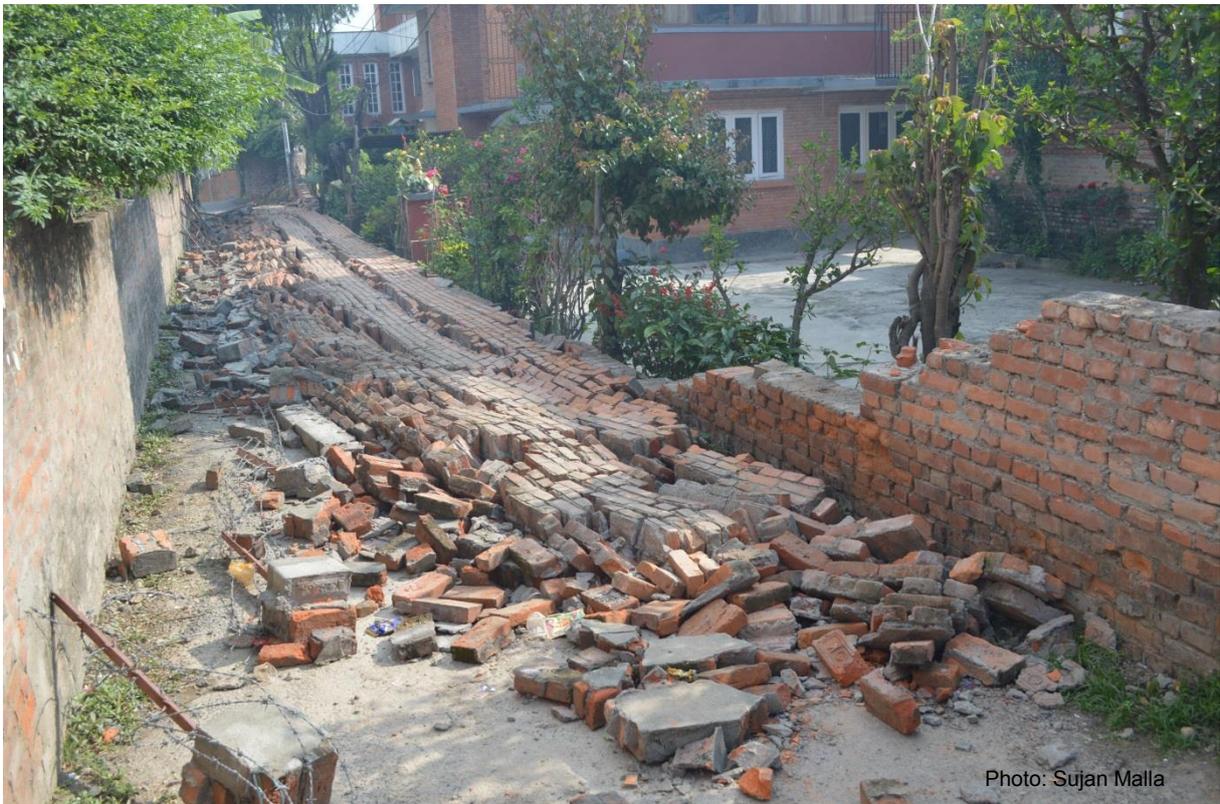
Photo 54 Collapsed boundary wall blocking a narrow access road in Kathmandu

Collapse of high boundary walls most probably caused casualties also in the 2015 Nepal earthquake disaster, although this has not been specially reported by the media focused on more spectacular building collapses. The collapse of high walls also blocked vehicle traffic through some narrow alleys in the Kathmandu Valley for many days after the earthquake, causing serious hindrances to disaster relief activities.

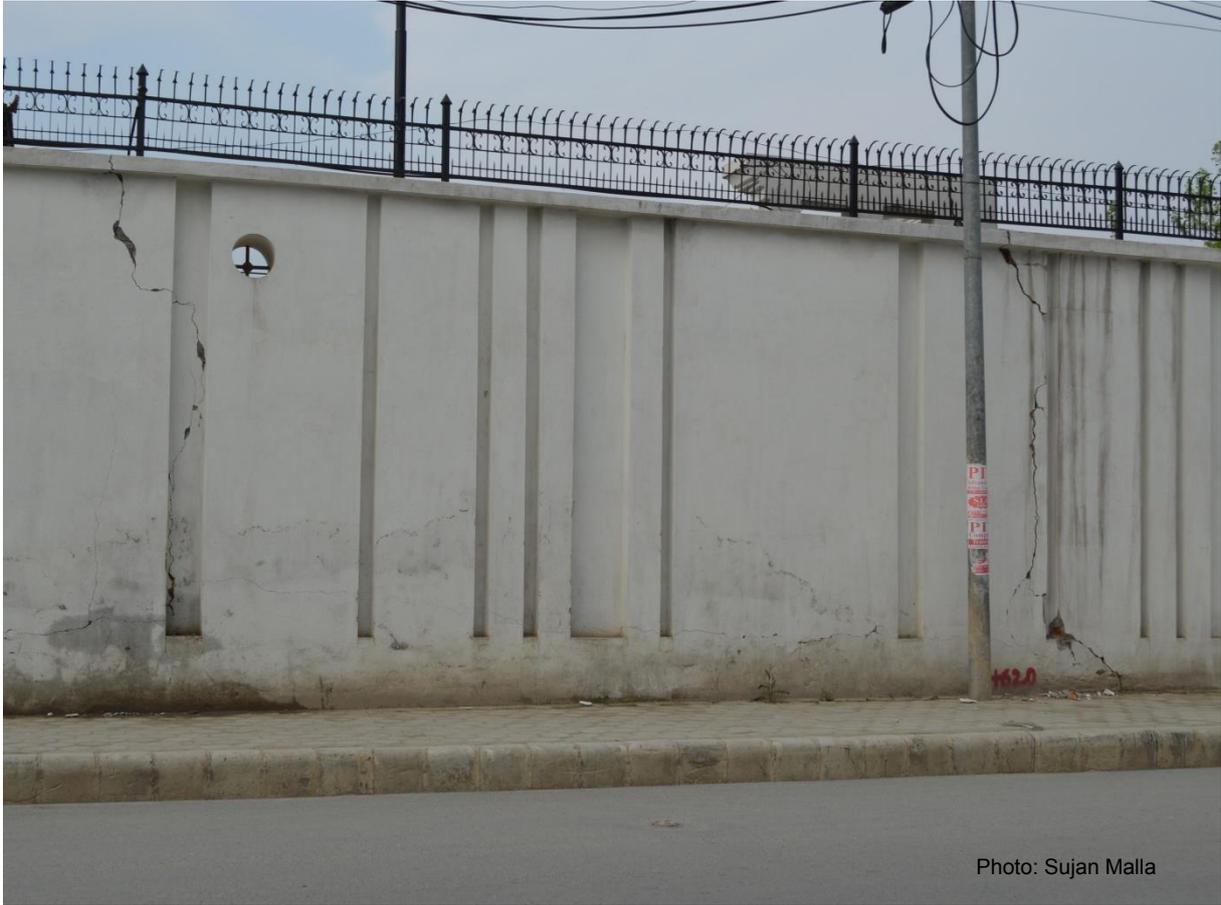
Photo 55 Very high boundary wall with significant earthquake-induced cracks in Kathmandu
